# Pre-shipment Inspection Report

Report #: PSI20230921&22-R2309133838

| General Information: | |
|---|---|
| Product name | Alum Box |
| PO# | 22003978 |

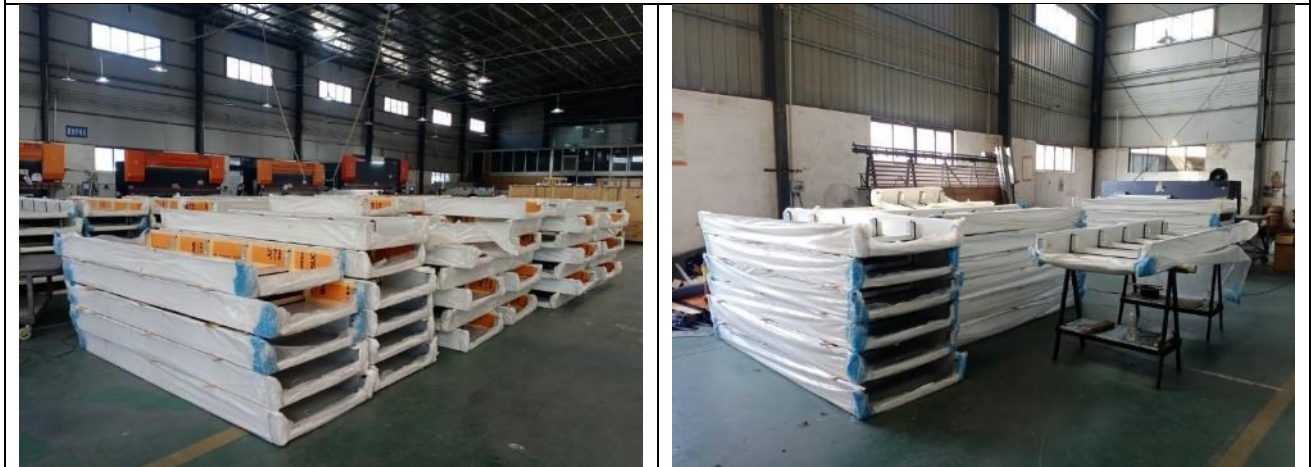
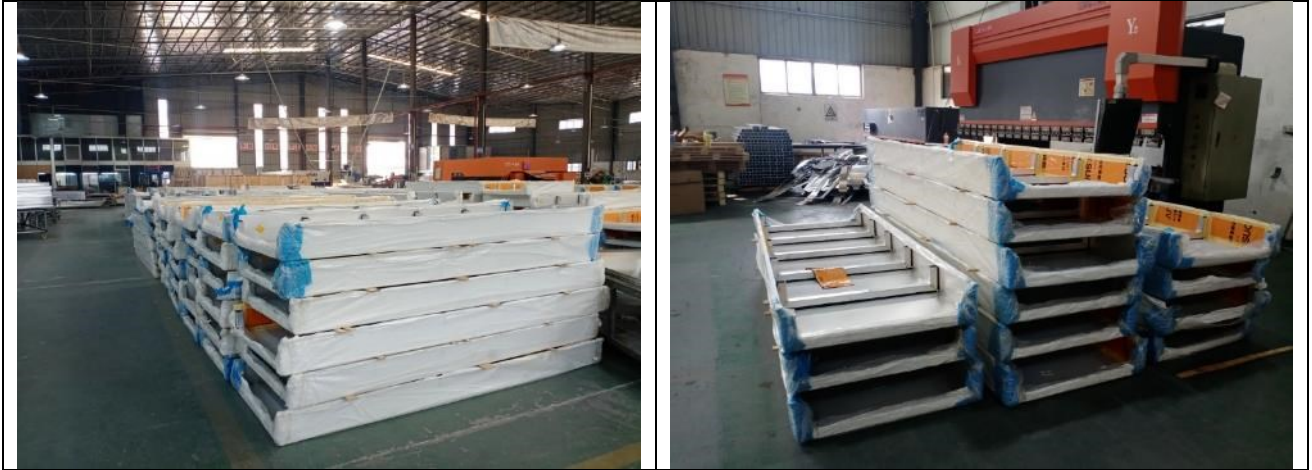
1. Remark 1.1 When the inspector arrived at the factory, the factory had already completed a batch of products (226pieces) and had not yet packaged them into boxes.

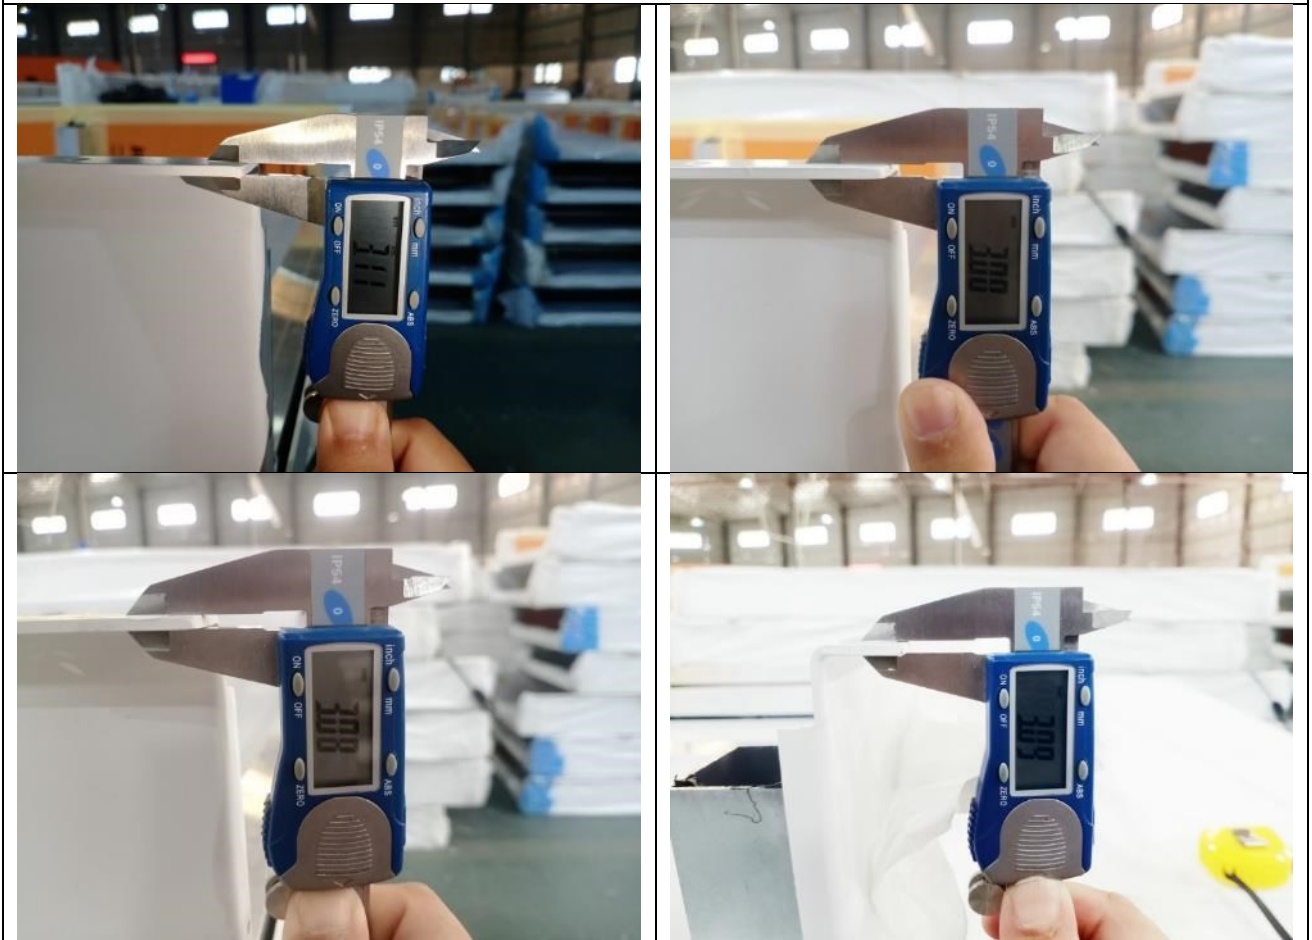
1. The material of which the boxes are made of is – aluminum alloy 5052H32 3 mm. thickness

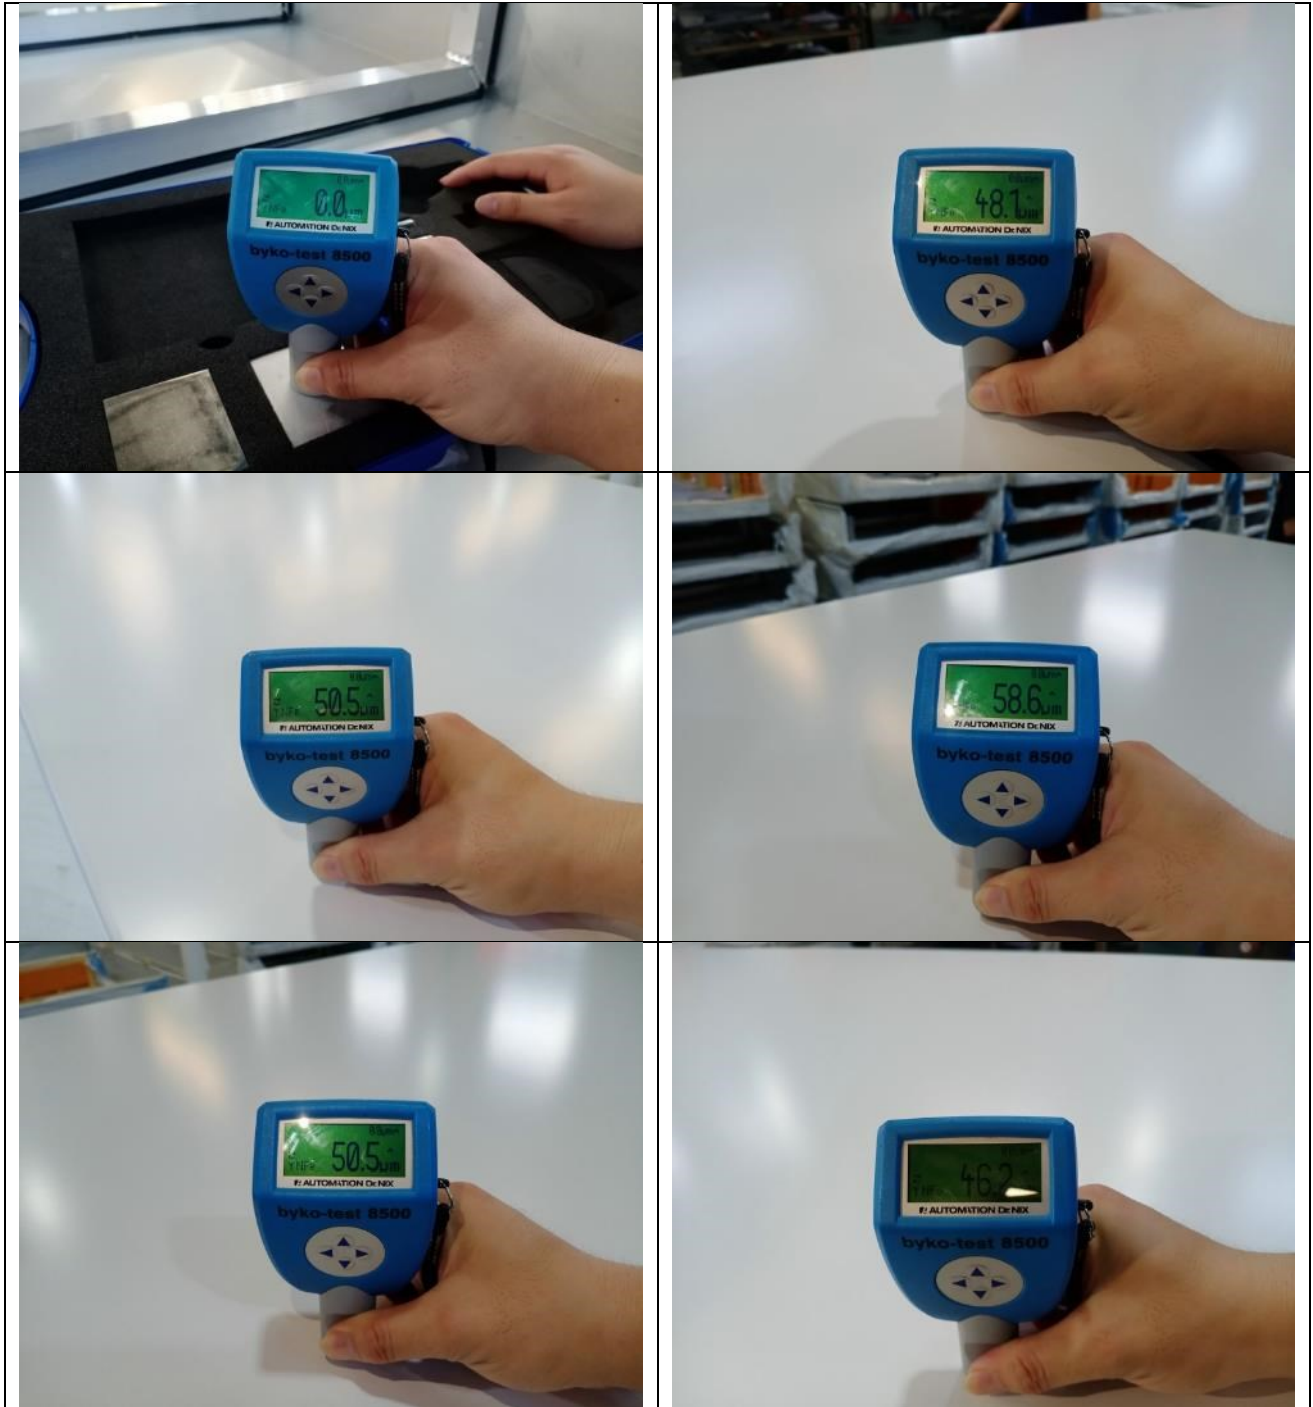
2. The coloring will be applied in 3 coats (PVDF3) 40>32  $\mu$ m thickness

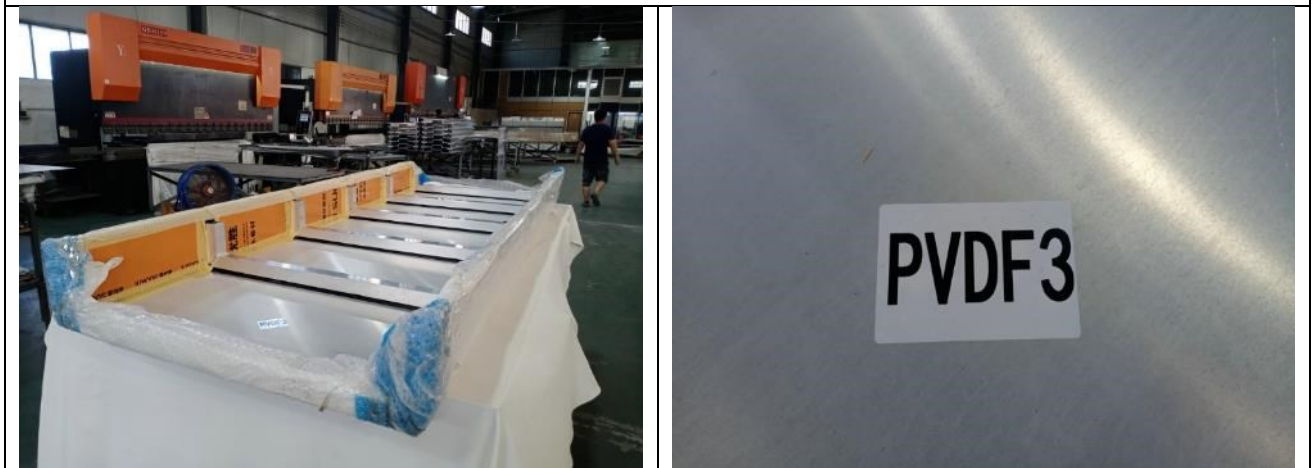
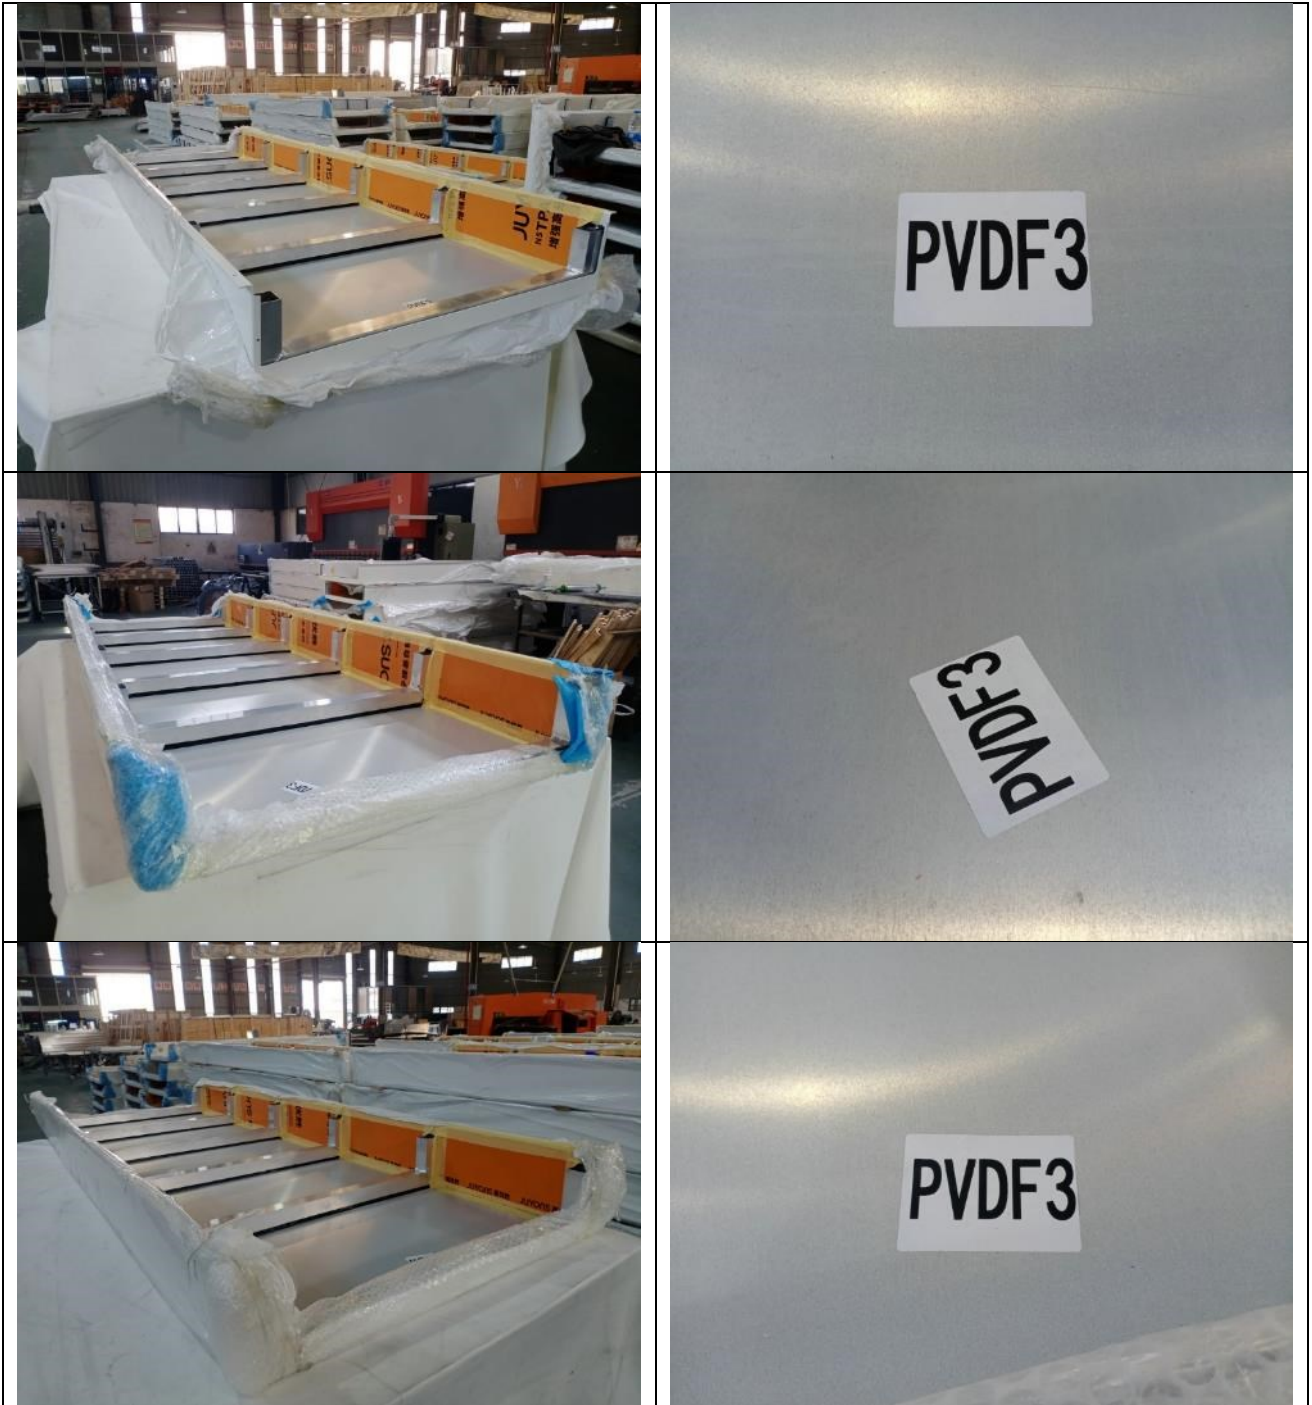
3. PVDF3 seal is printed inside the box

4.As per the client requirement, The finish of the inner part of the boxes should be passivation10µm thickness, but factory missing this process.

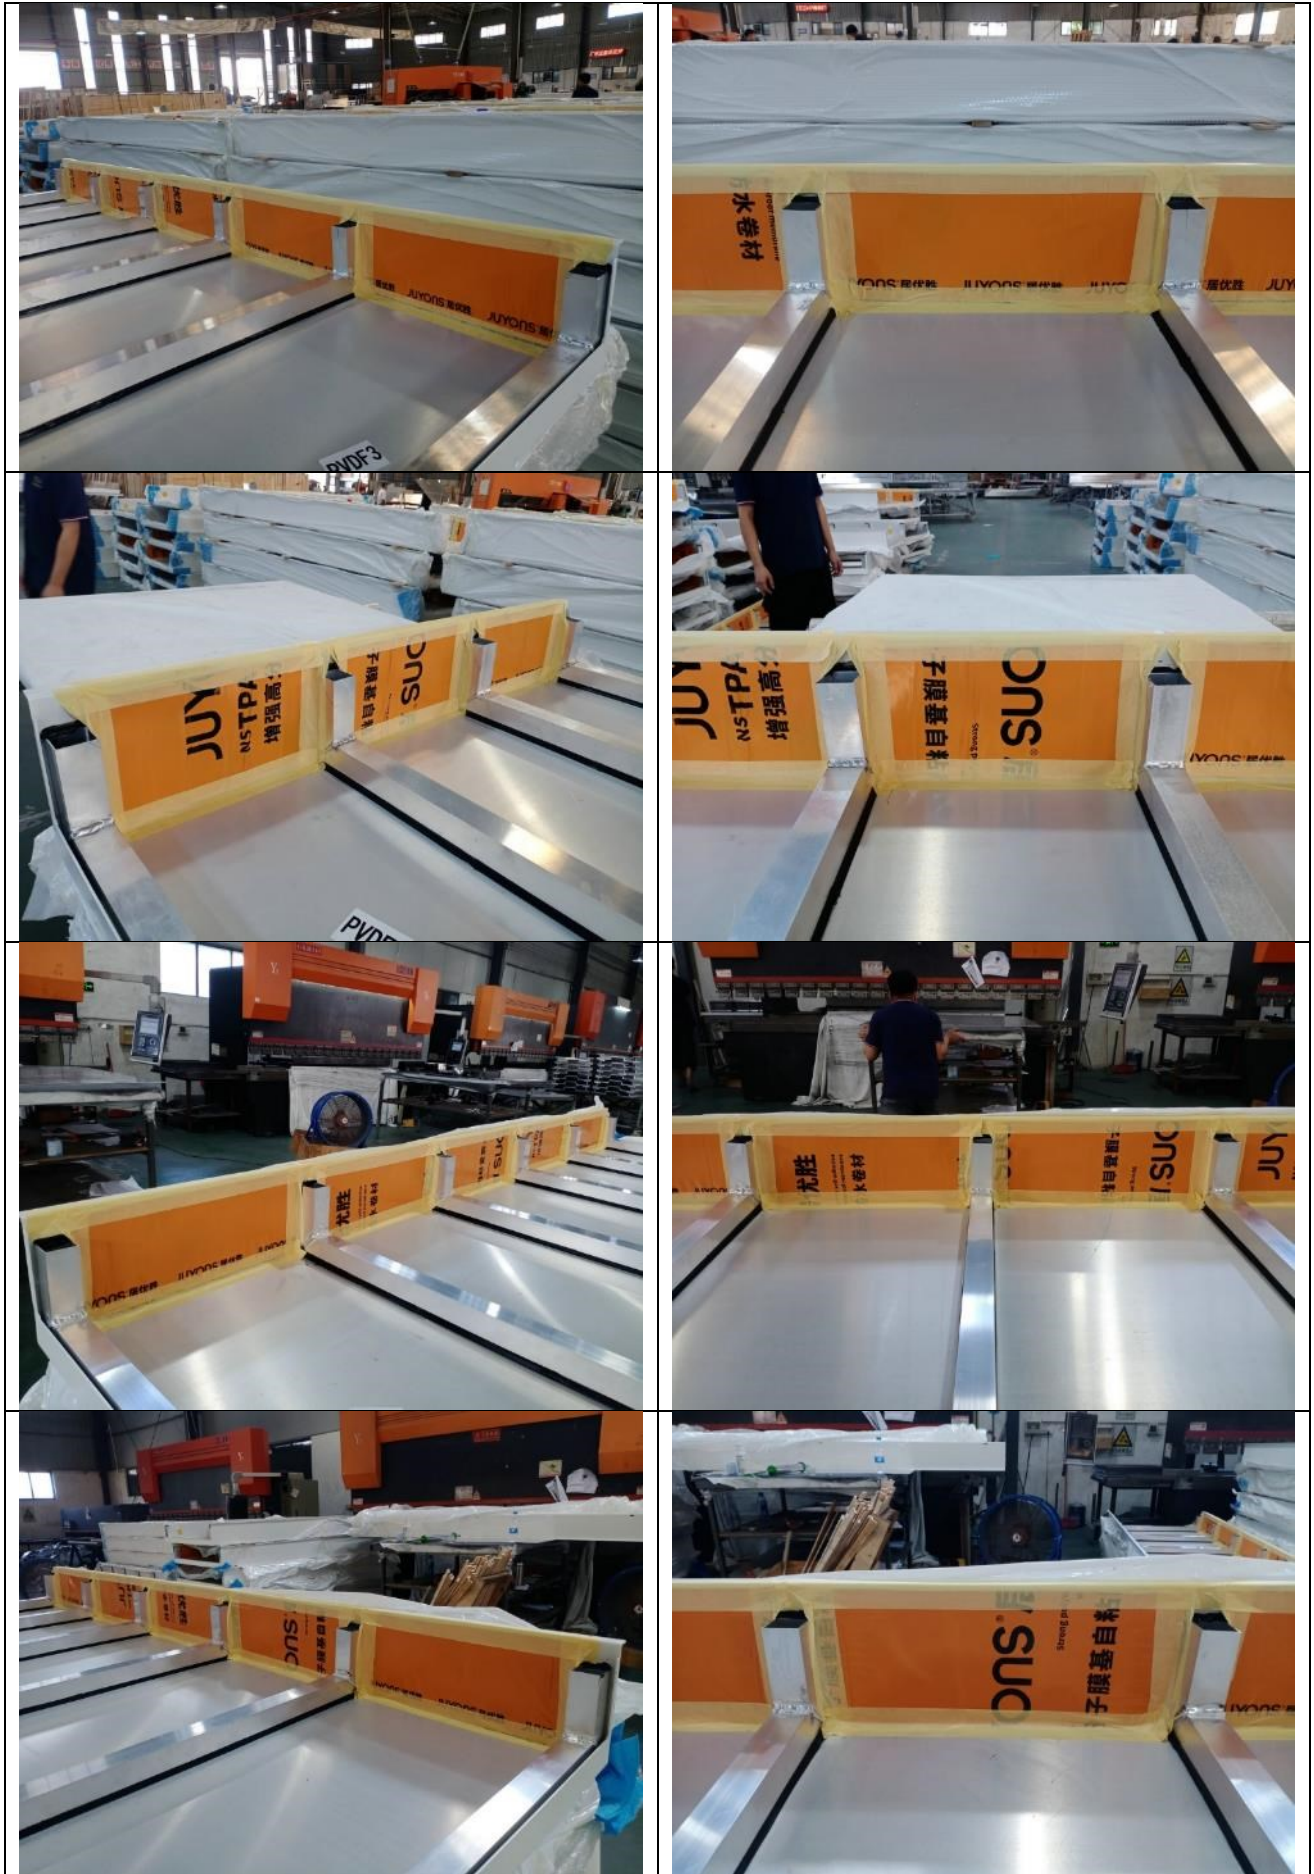
5. Only when the inspector arrives at the factory, the products have all completed the installation and reinforcement of the sound insulation film. The factory uses tape to stick all the edges together.

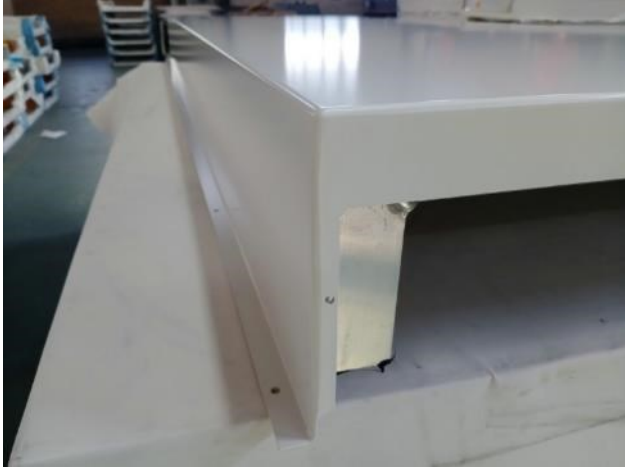
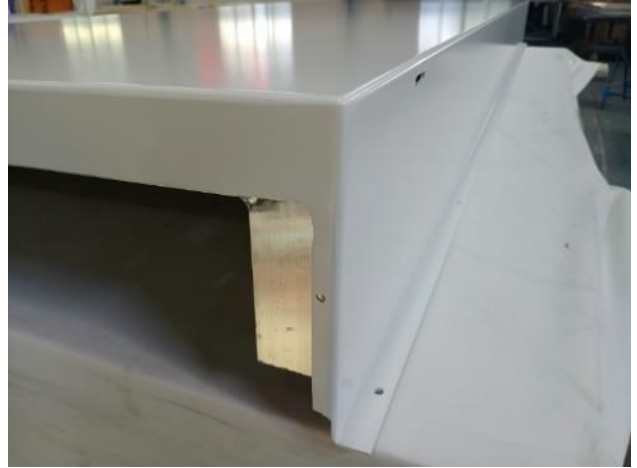
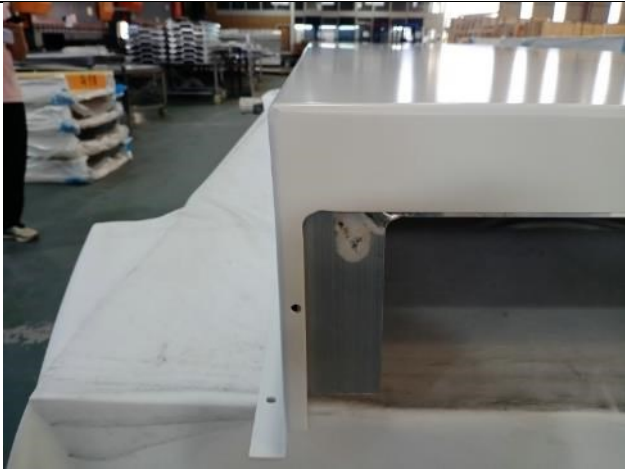
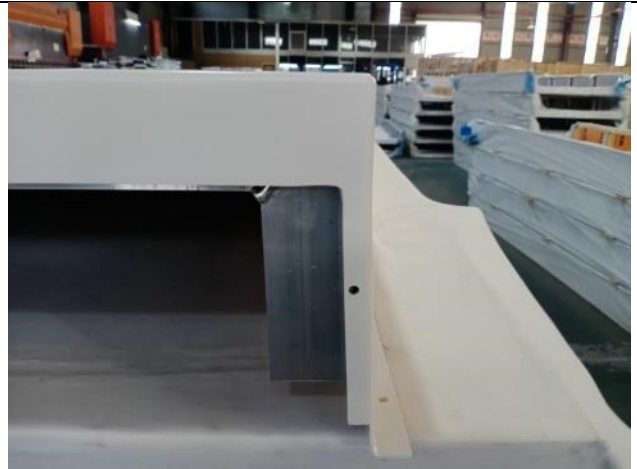
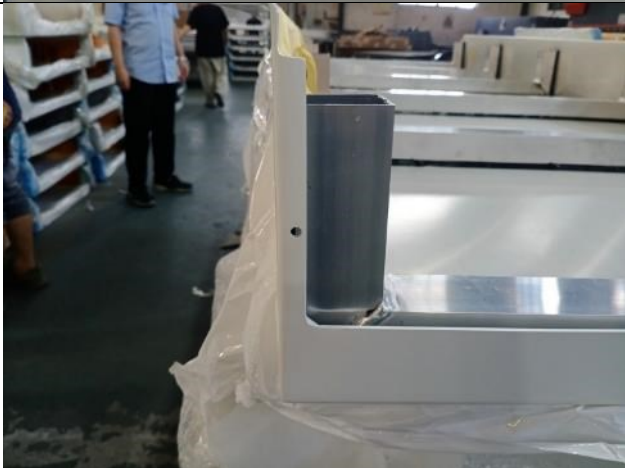
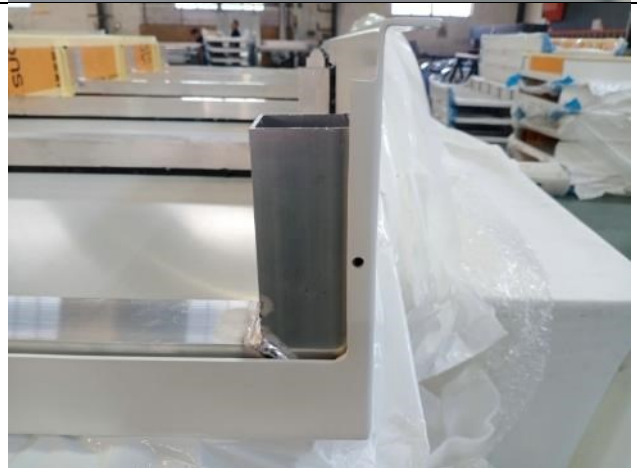
9.Edge of the box

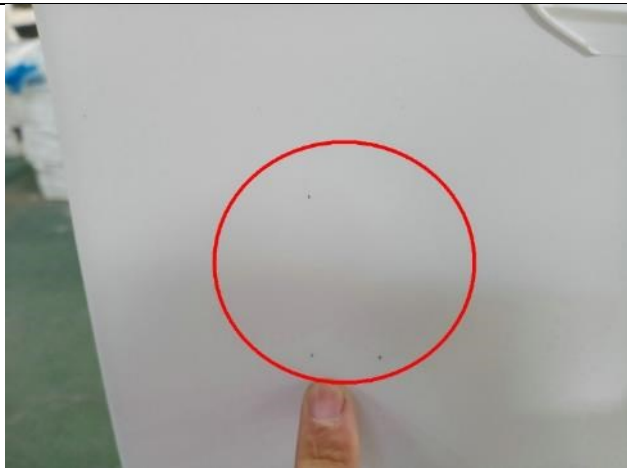
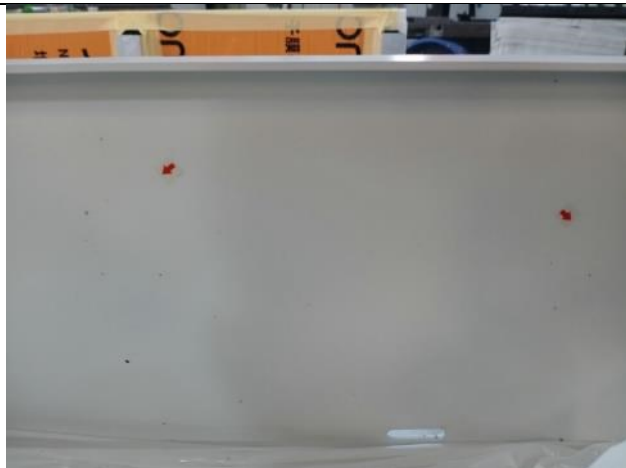
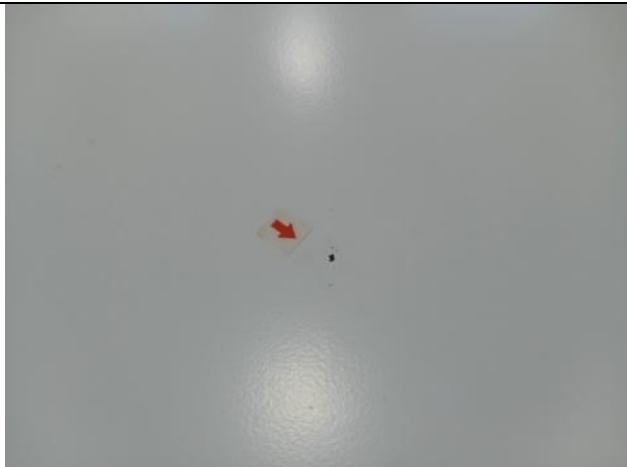
| Item: HP-1 | | | | | |

| HP-1 | Black particles on the surface | 0 | 0 | 3 | |
| Black particles on the surface-Min | | Black particles on the surface-Min | | | |

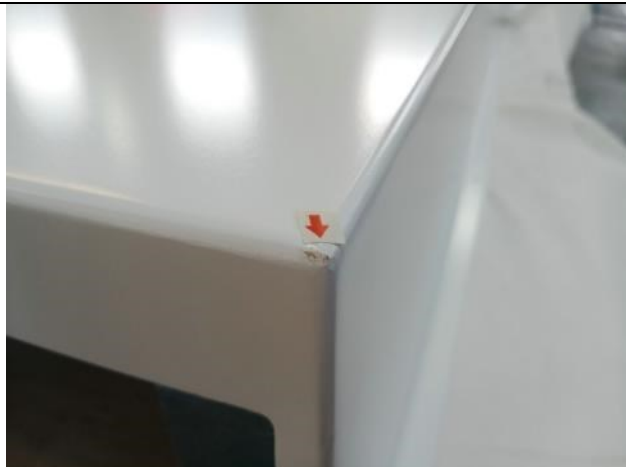
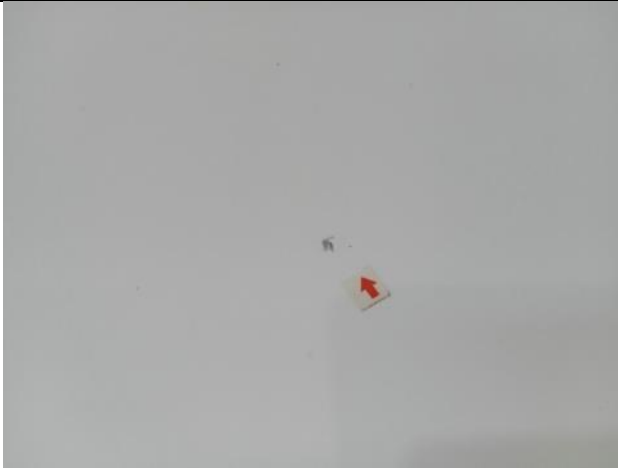
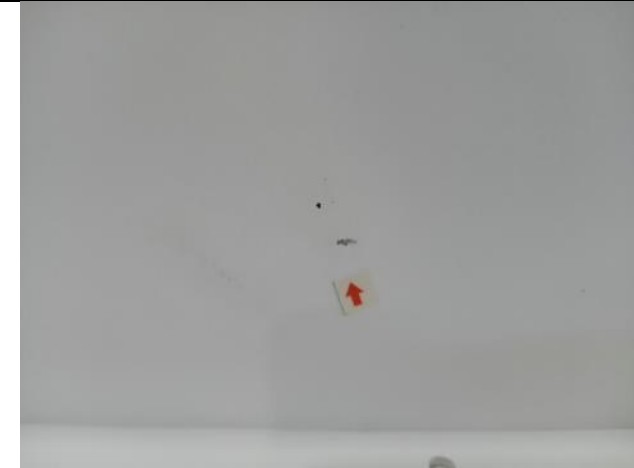
| | Damaged edges and corners with paint | 0 | 3 | 0 | |
| Black particles on the surface-Min | | Damaged edges and corners with paint-Maj | | | |

| Damaged edges and corners with paint-Maj | Damaged edges and corners with paint-Maj |

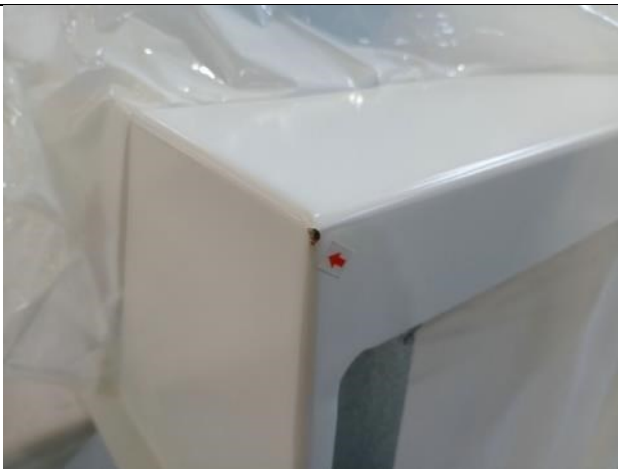
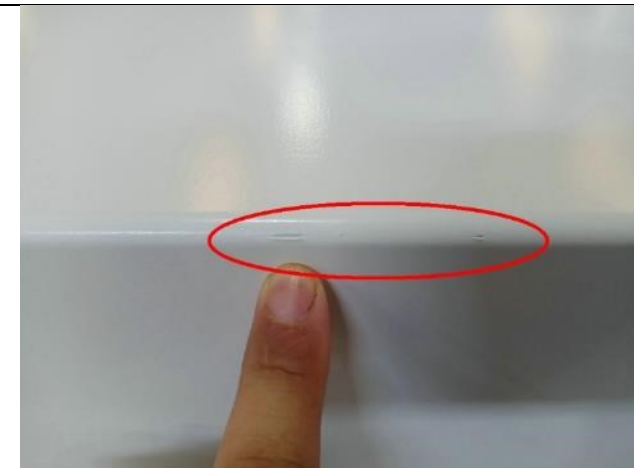
| Item:HP-2 | |

| HP-2 | Damaged edges and corners with paint | 0 | 1 | 0 | |

| Damaged edges and corners with paint-Maj | Spray defects-Min |
| Spray defects-Min | Damaged edges and corners with paint-Min |

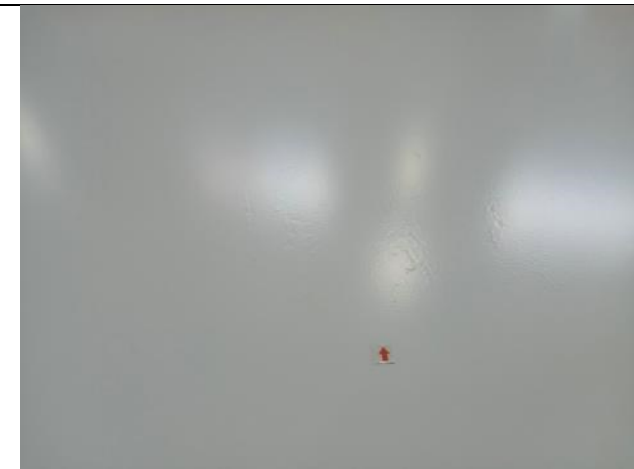
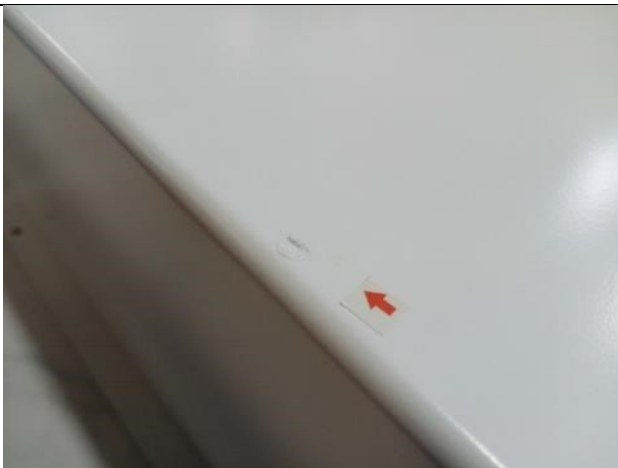
| | Spray defects | 0 | 0 | 2 | |

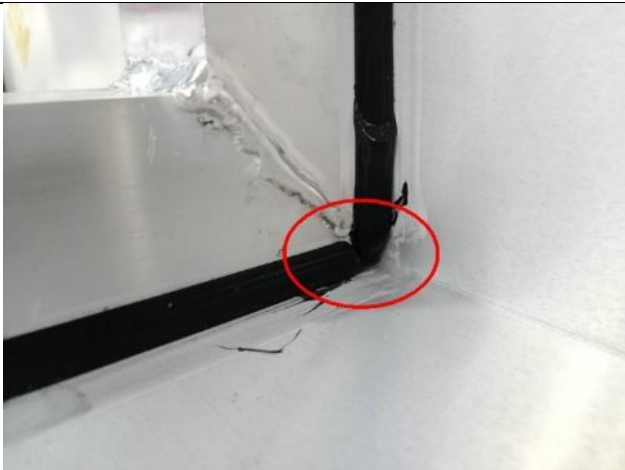
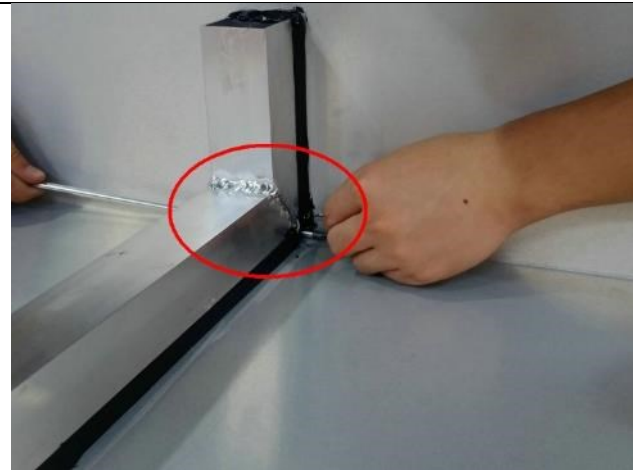
| Item:HP-6 | |

| HP-6 | Some drainage outlets inside are blocked | 0 | 2 | 0 | |

| <p>Some drainage outlets inside are blocked-Maj</p> | <p>Some drainage outlets inside are blocked-Maj</p> |

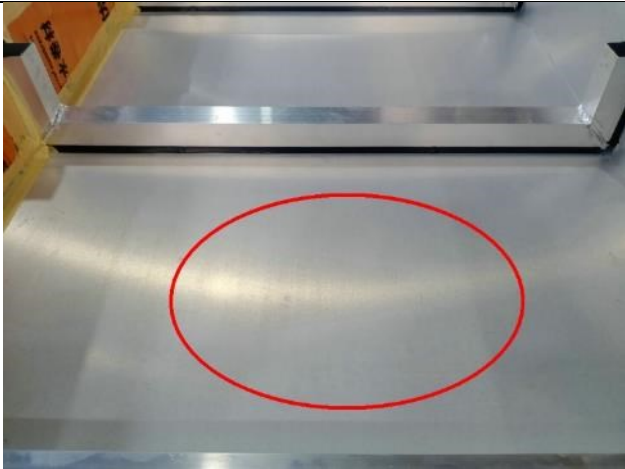
| Client's requirements | Comments |
|---|---|
| 3.PVDF3 stamp imprint on the inner part of the boxes | Missing PVDF3 label inside the HP-6 product box |

| | Missing PVDF3 label inside | 0 | 1 | 0 | |

| <p>Missing PVDF3 label inside -Maj</p> | <p>N/a</p> |

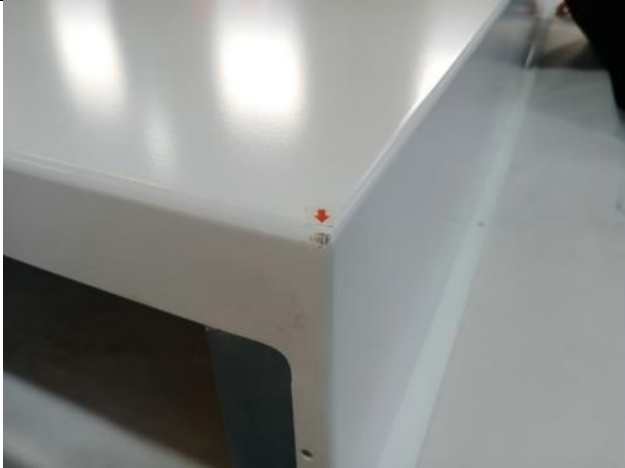
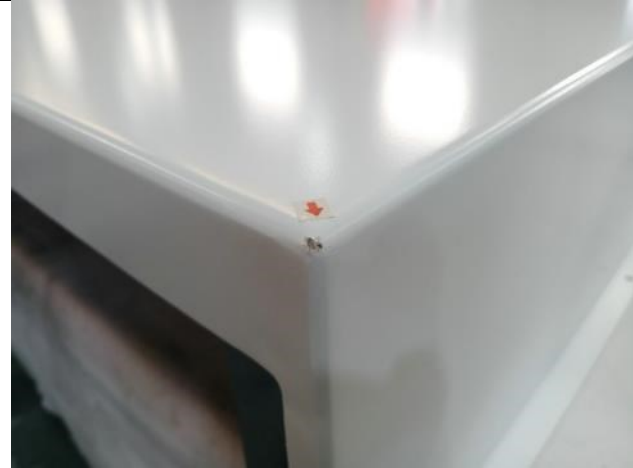
| <p>Item:HP-7</p> | |

| HP-7 | Damaged edges and corners with paint | 0 | 2 | 0 | |

| <p>Damaged edges and corners with paint-Maj</p> | <p>Damaged edges and corners with paint-Maj</p> |

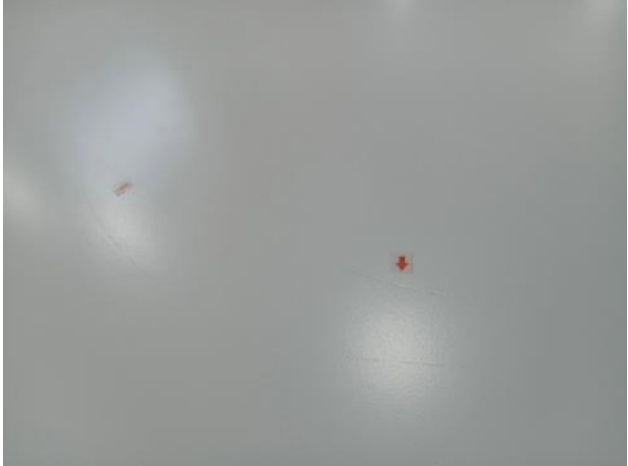
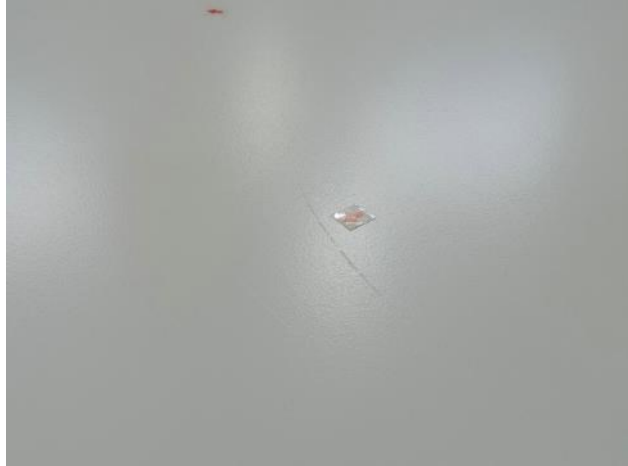
| | Multiple scratches on the surface of the topcoat (not visible at 1 meter of the product) | 0 | 0 | 1 | |

| Multiple scratches on the surface of the topcoat (not visible at 1 meter of the product)-Min | |

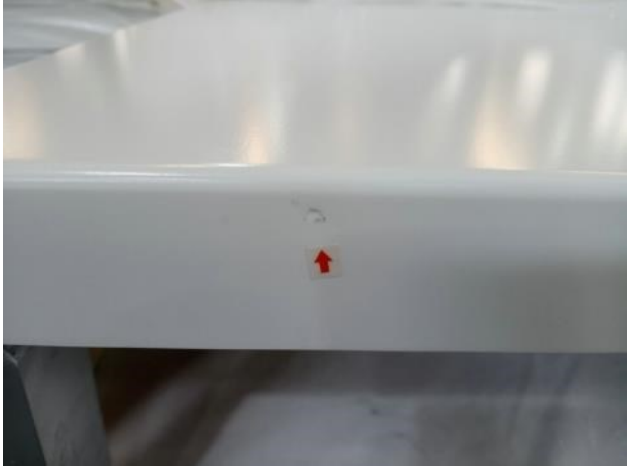
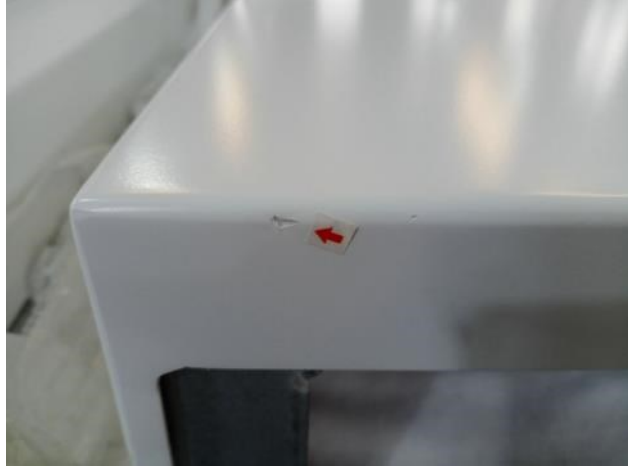
| Item:HP-8 | |

| HP-8 | Damaged edges and corners with paint | 0 | 2 | 0 | |

| Damaged edges and corners with paint-Maj | Damaged edges and corners with paint-Maj |
