# Pre-shipment Inspection Report

Report #:PSI20200413-200331-H

| General Information: | |
|---|---|
| Product name | SUNGLASSES |

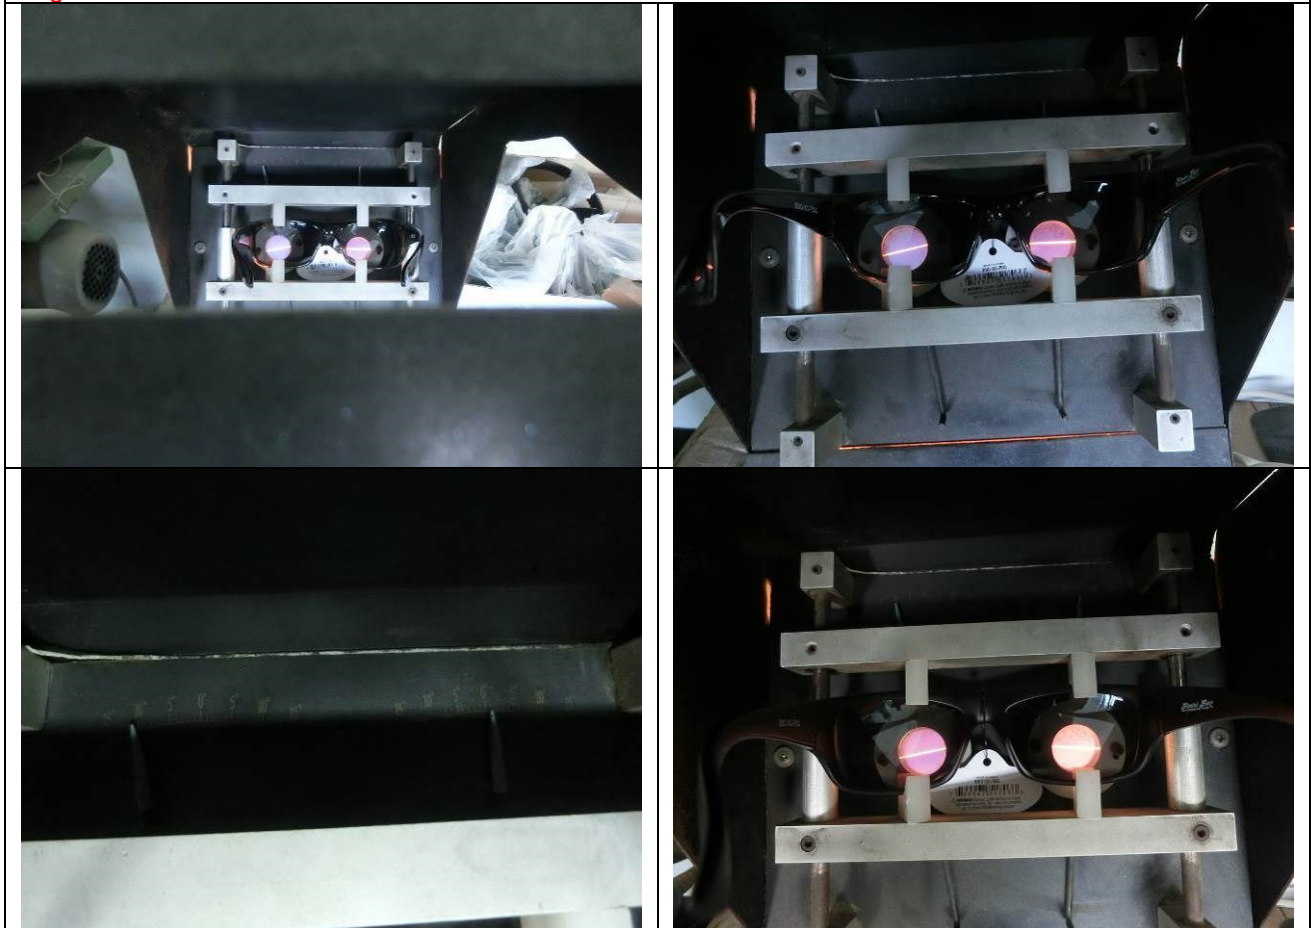
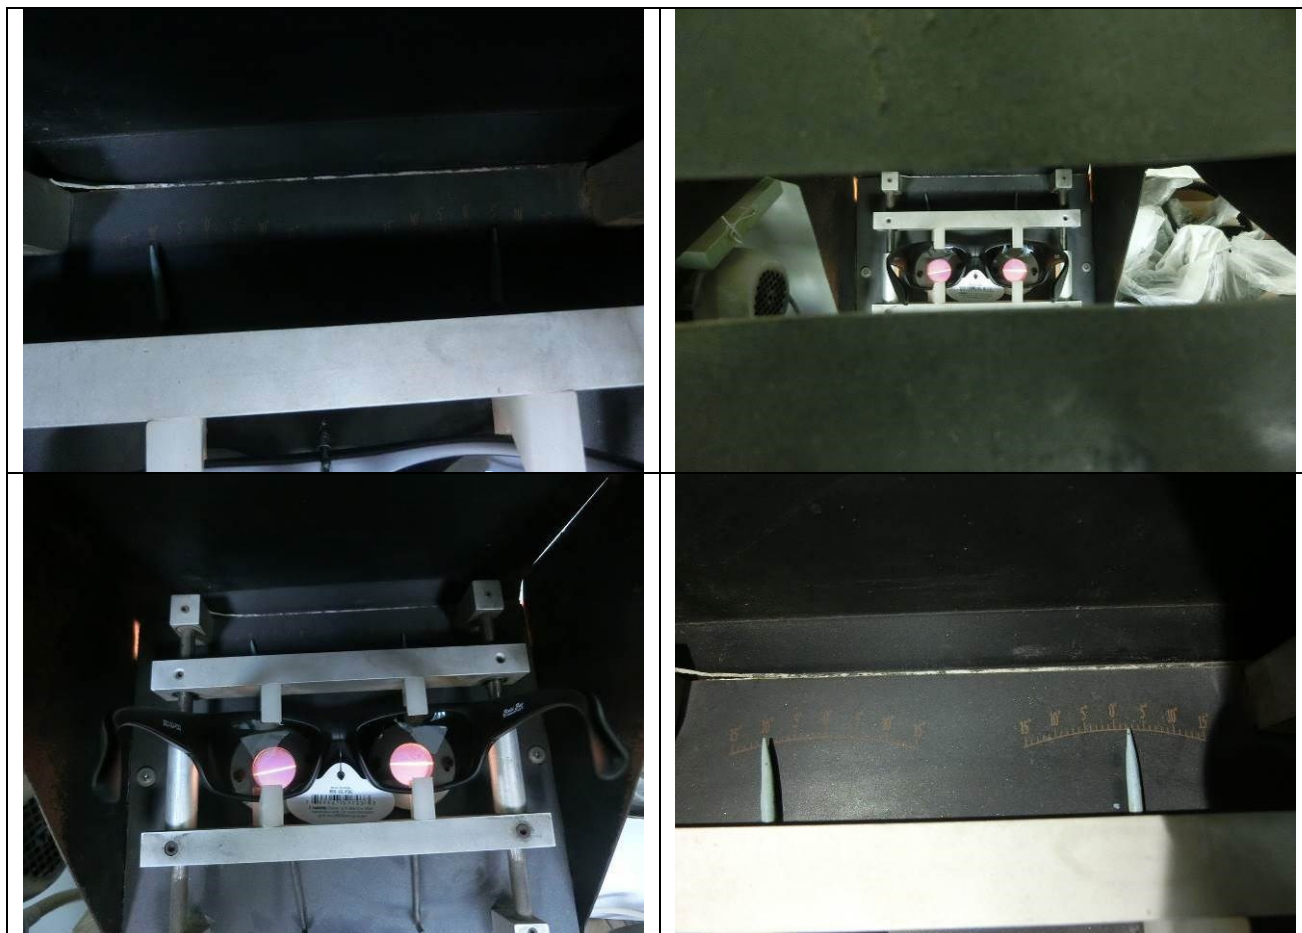
| 3.2. | For 91207 Smoke/Blue Mirror Polarized light test, found result was 9-10 degree beyond +/-3 degree. |

Remark #3.2: For 91207 Smoke/Blue Mirror Polarized light test, found result was 9-10 degree beyond +/-3 degree.

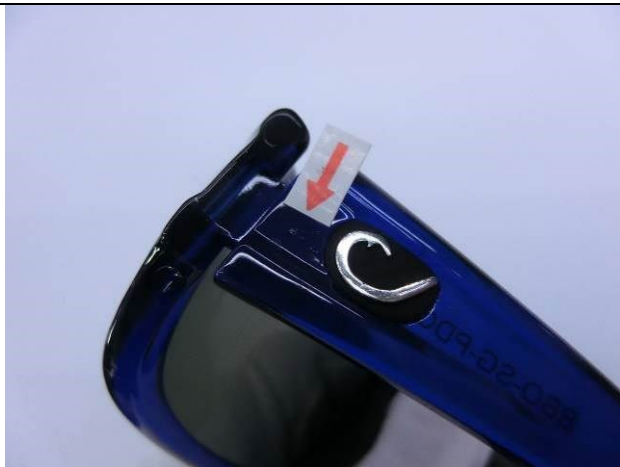
Item: 14318

Glue mark on frame-minor

| # | Description | Cri. | Maj. | Min. | Remarks |
|---|---|---|---|---|---|
| 14318 | Glue mark on frame | | | 1 | Reworked |

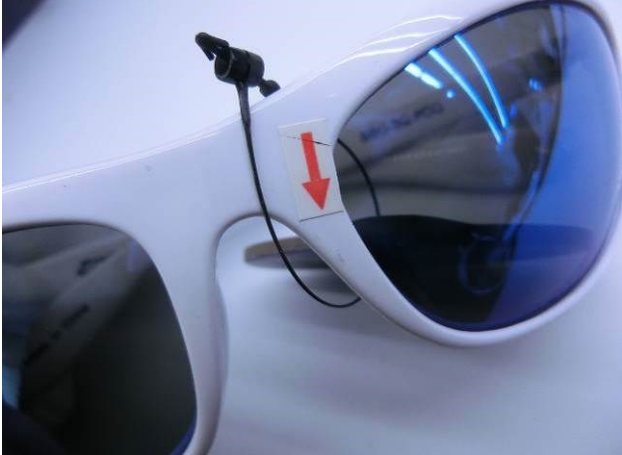
| <p>Item: 91201</p> | |

| <p>Color stain on frame-minor</p> | <p>Scratch mark on frame-minor</p> |

| 91201 | Color stain on frame | | | 1 | Replaced |

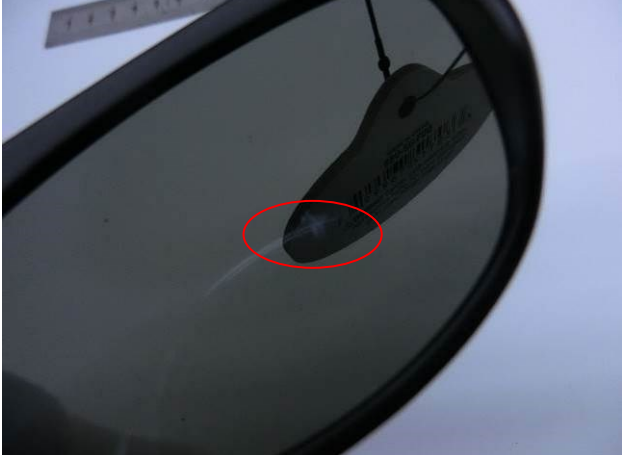
| <p>Dirty mark on lens-minor</p> | <p>Particle on frame-minor</p> |

| | Dirty mark on lens | | | 1 | Reworked |

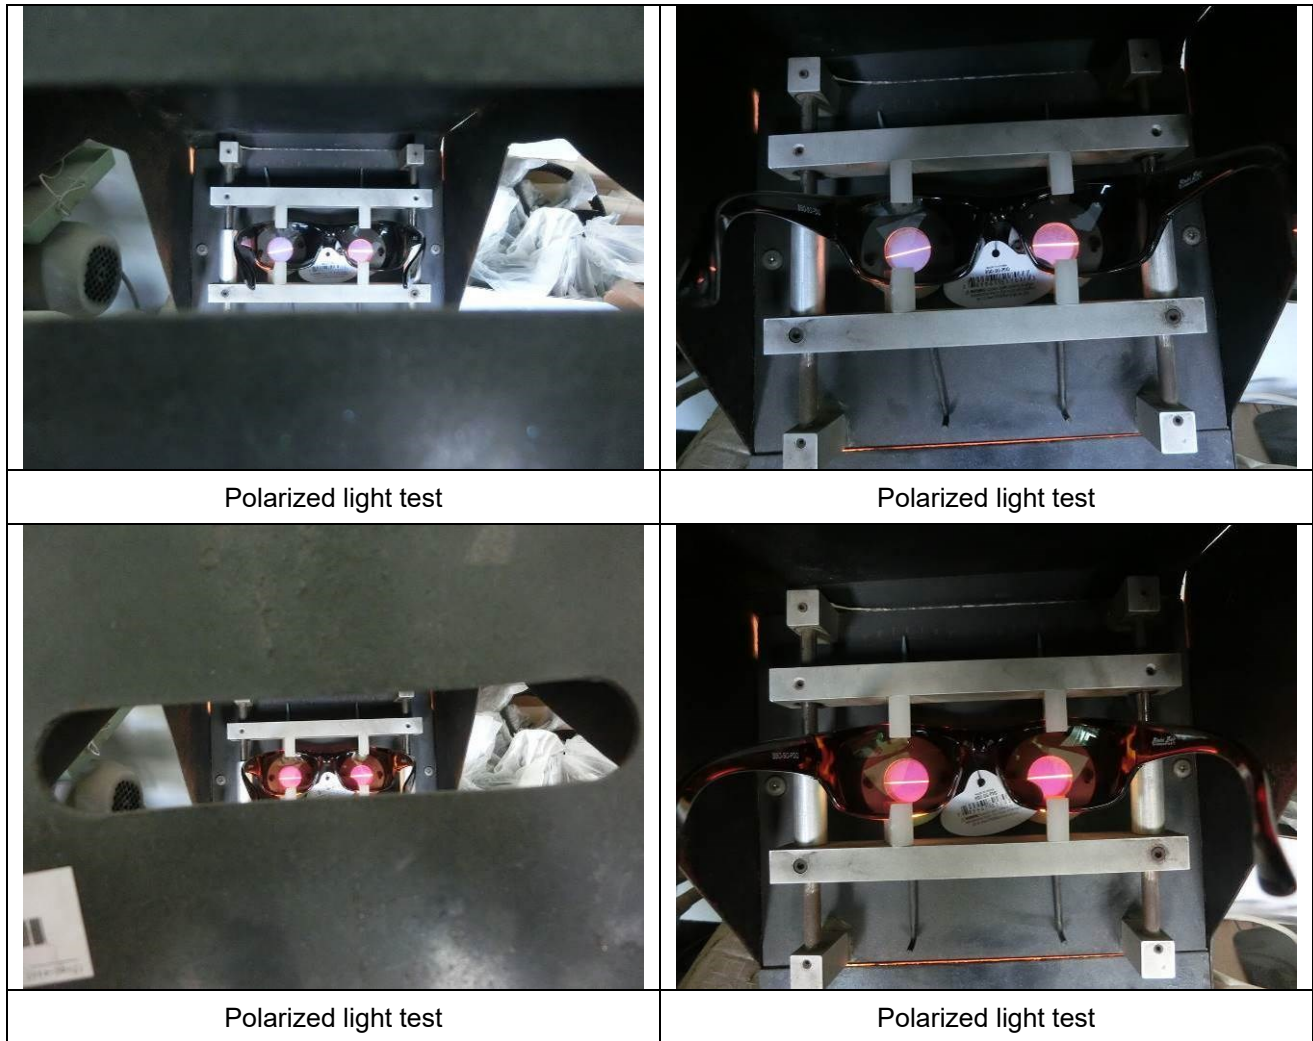
| # | Testing Description | Sample Size | Result | Remark |
|---|---|---|---|---|
| 3.4. | Polarized light test | 1 pc/item | Pending | For 91207 Smoke/Blue Mirror Polarized light test, found result was 9-10 degree beyond +/-3 degree. |

Polarized light test
