# Pre-shipment Inspection Report

Report #: PSI20211130-R211101260

| General Information: | | |
|---|---|---|
| Product name | Power Bank | |

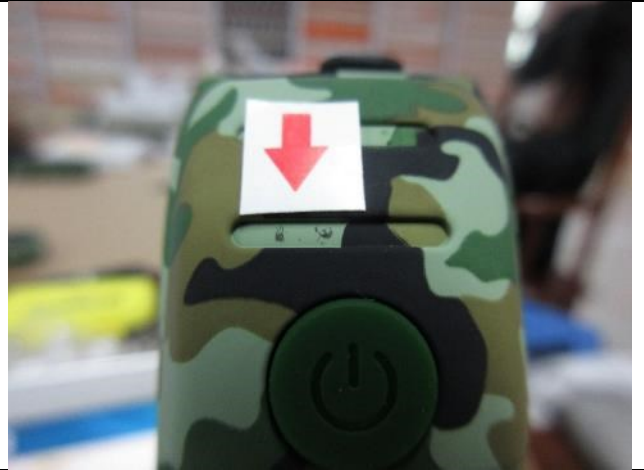
| AQI Remarks | |
|---|---|
| 2.2. | <b>Poor water transfer printing 100% on the back. They are not recorded in workmanship table.</b> |

Poor water transfer printing - Minor

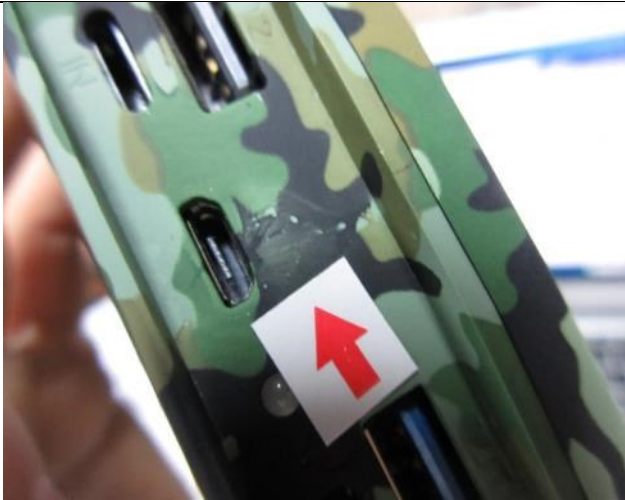
Poor water transfer printing - Minor

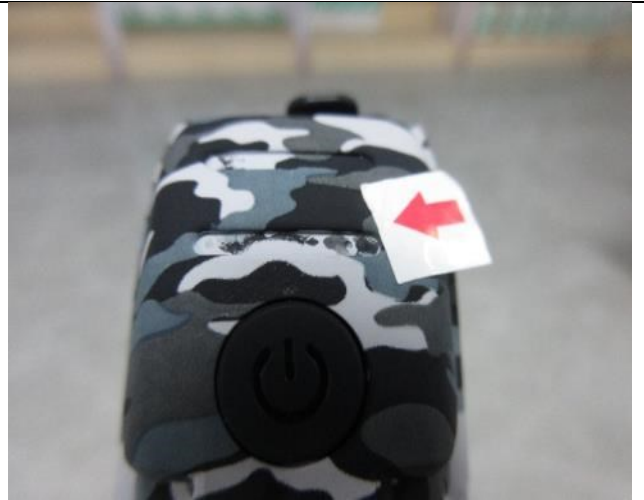
Poor water transfer printing - Minor

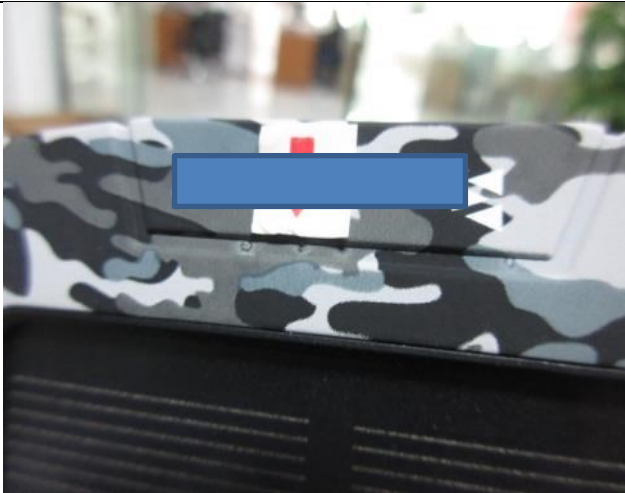
Poor water transfer printing - Minor

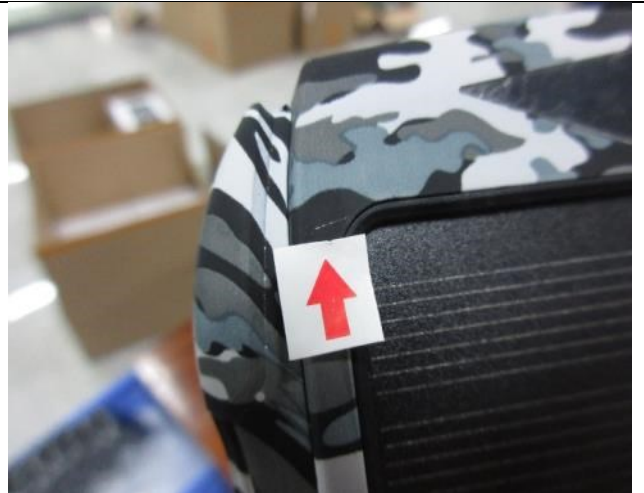
| # | Description | Cri. | Maj. | Min. | Remarks |
|---|---|---|---|---|---|
| 2.3 | Scratch mark | | | 1 | |

Scratch mark - Minor

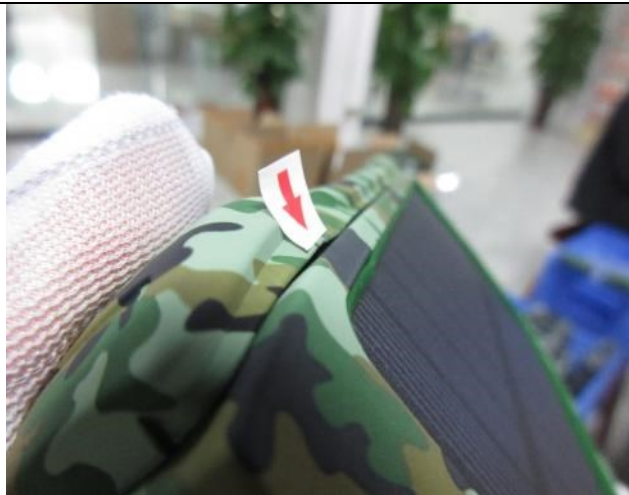
| # | Description | Cri. | Maj. | Min. | Remarks |
|---|---|---|---|---|---|
| 2.4 | Gap | | | 1 | |

| Gap - Minor | Incomplete of solar panel - Major |

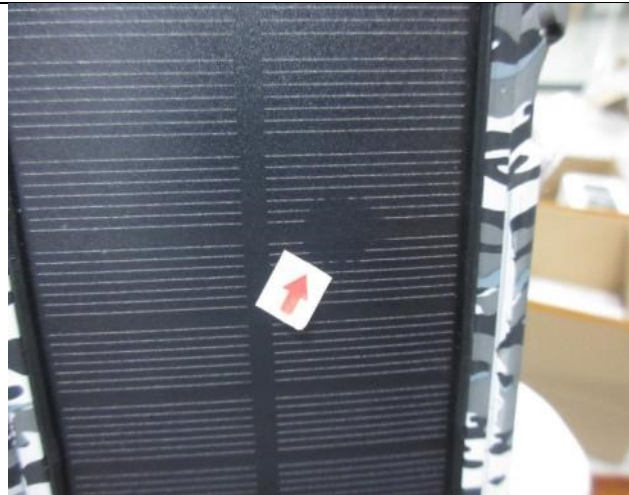
| # | Description | Cri. | Maj. | Min. | Remarks |
|---|---|---|---|---|---|
| 2.5 | Incomplete of solar panel | | 1 | | |

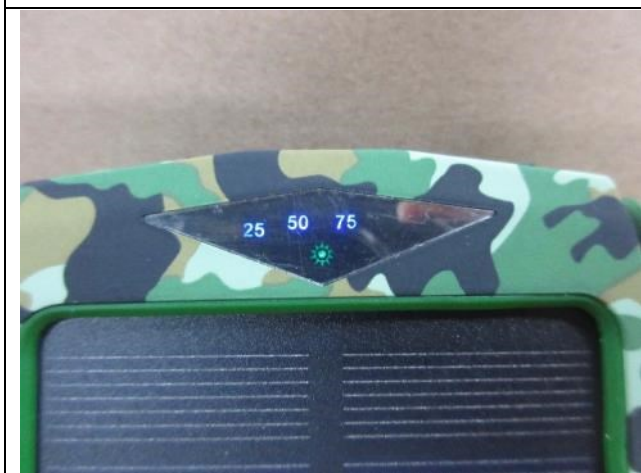
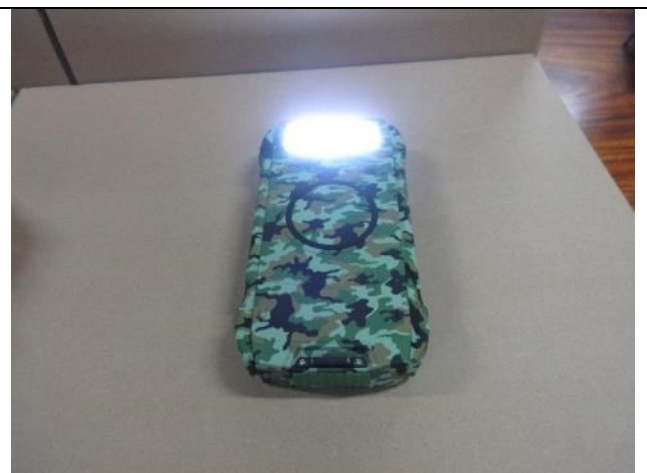
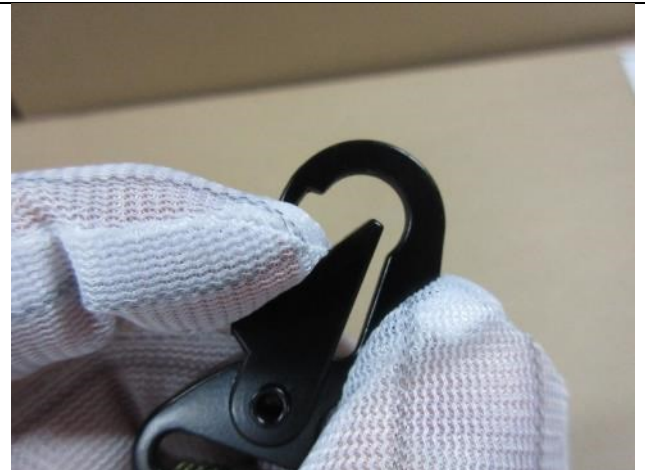
| 3.2. | For LED Camping light function, the product only has strong light mode, no SOS mode and strobe Mode, which was not conform the manual, pls refer video. |

| # | Testing Description | Sample Size | Result | Remark |
|---|---|---|---|---|
| 3.6. | Application check<br>Perform real operation on the product, Charging function, Power switch function, Led light function | 1 pc/item | Fail | Remark 3.2 |

Application check

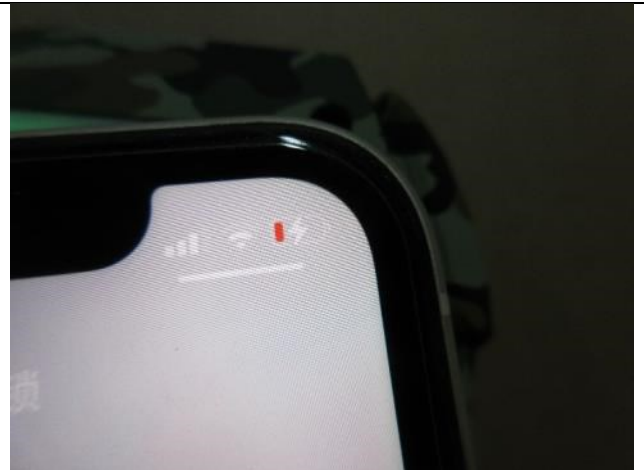
| # | Testing Description | Sample Size | Result | Remark |
|---|---|---|---|---|
| 3.7. | Output current loading test<br>By DC Load meter | All samples | Pass | |

Output current loading test
