# Pre-shipment Inspection Report

Report #: PSI20230921&22-R2309133838

| General Information: | |
|---|---|
| Product name | Alum Box |
| PO# | 22003978 |

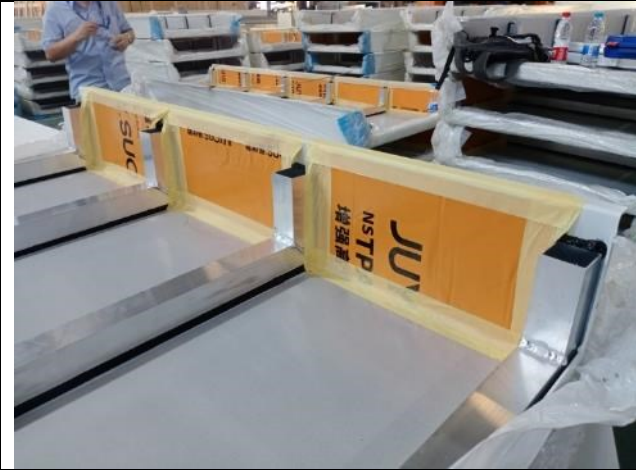
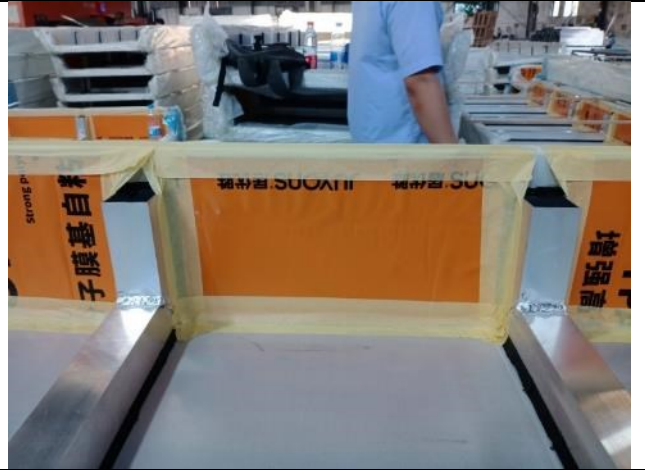
6. Clear water passage of the square shaped profiles, 5x5mm

All installations are completed and cannot be measured on site.

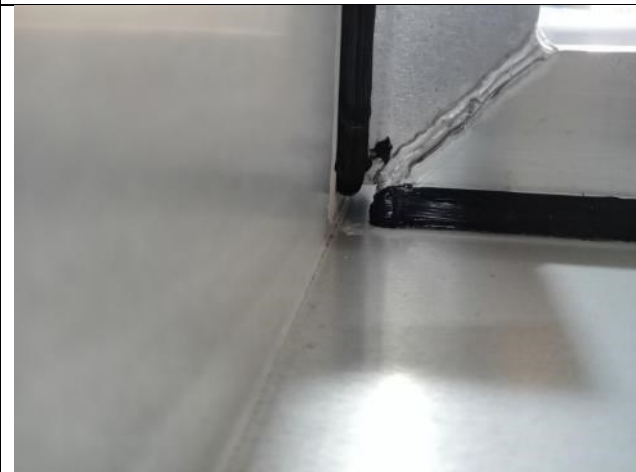
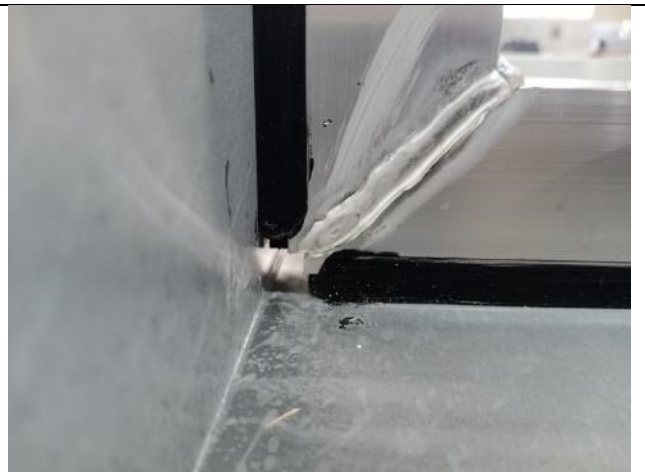
7. Welding thickness test, 4mm ~5mm

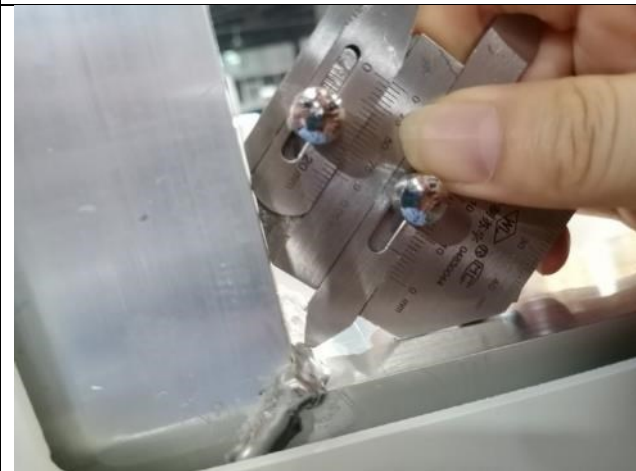
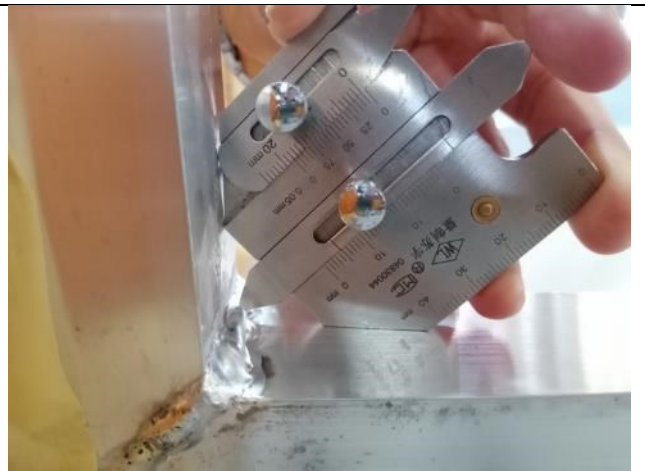
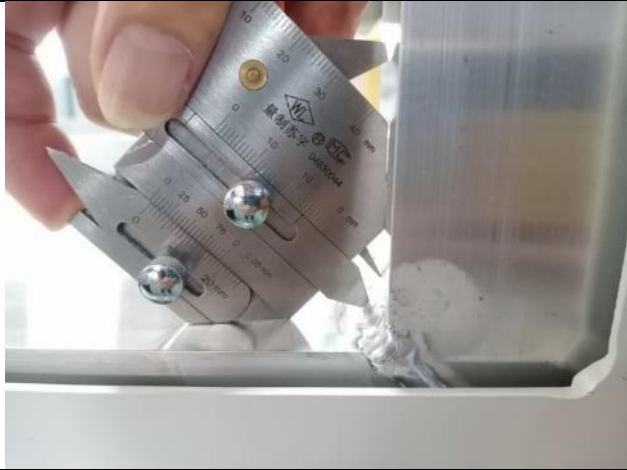
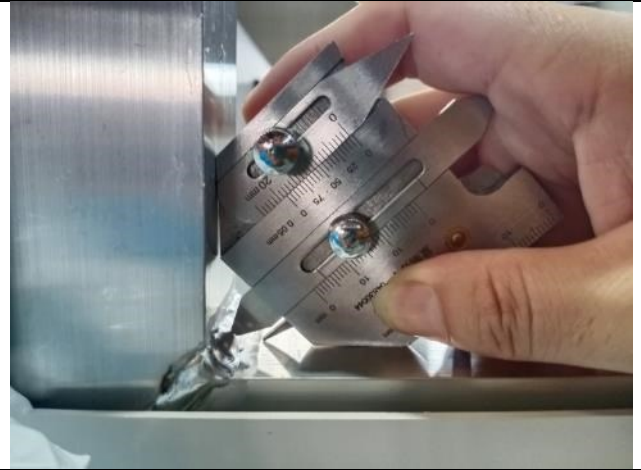
8. The reinforcement in the middle were welding from 3 sides, the welding was done with gap

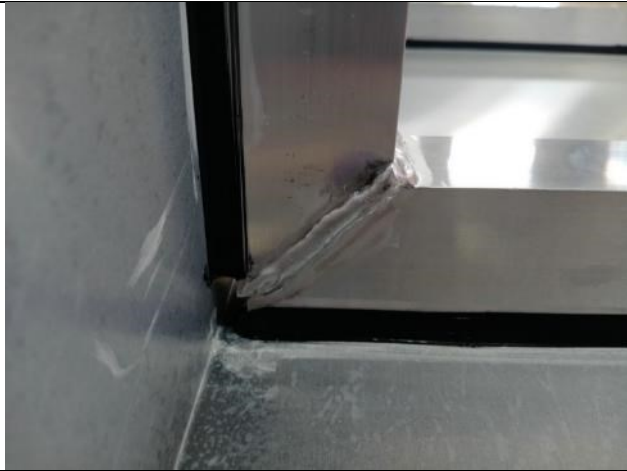
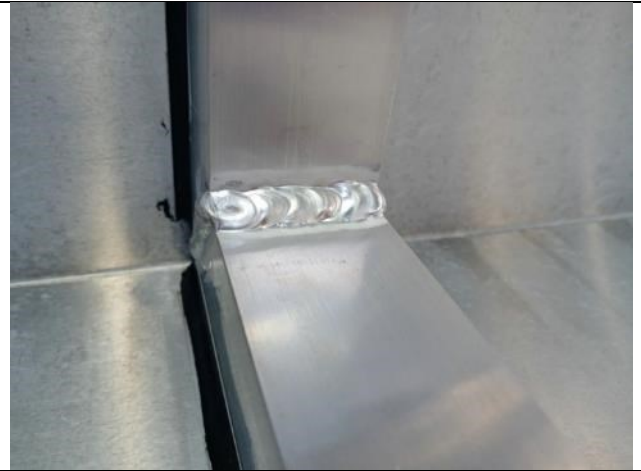
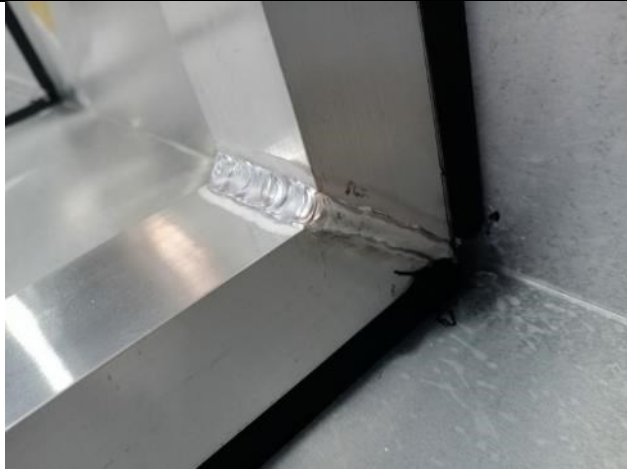
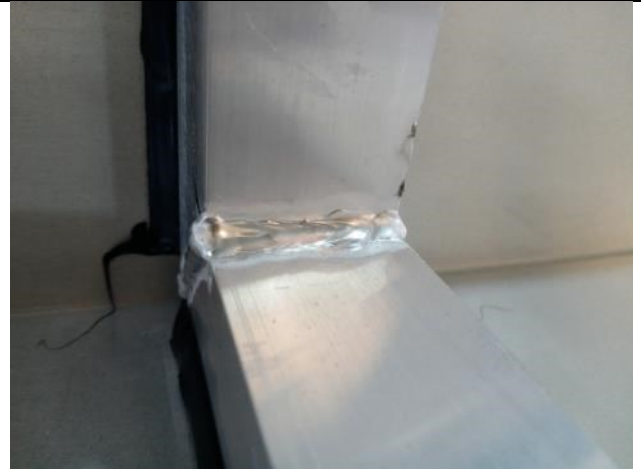
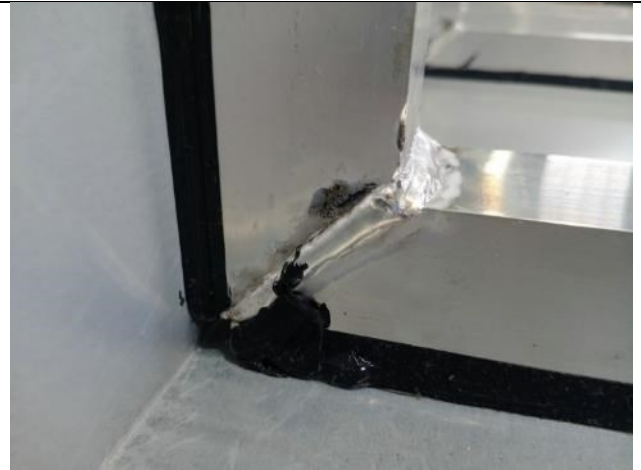
9.Edge of the box

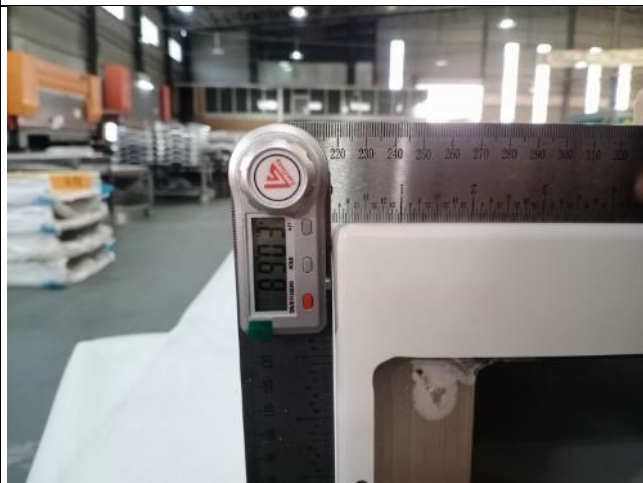
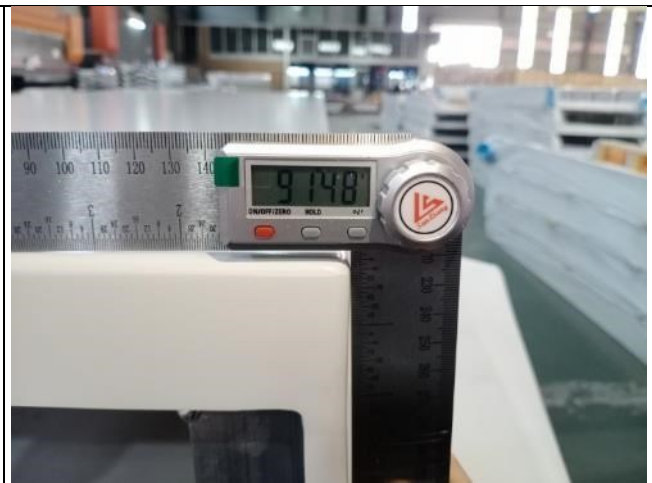
SPC 2:  $89.03^\circ$  ,  $91.48^\circ$

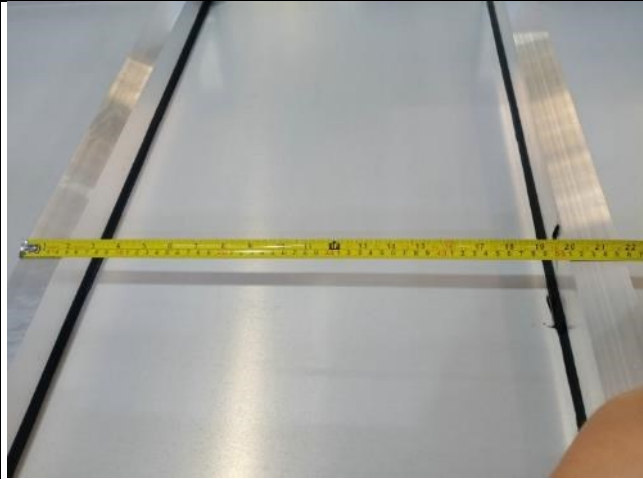
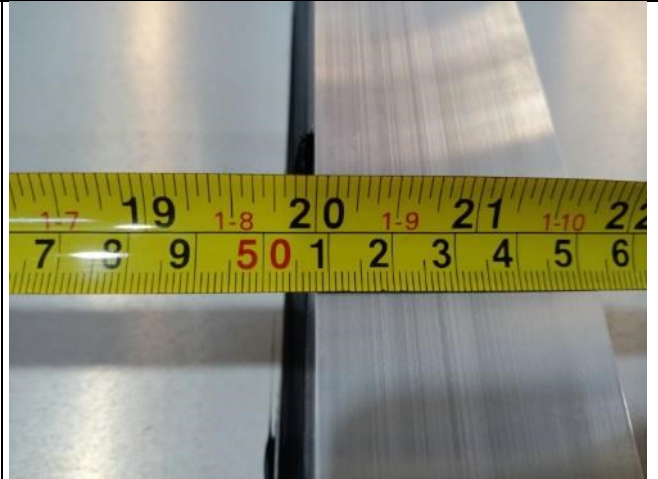
SPC 3: (reinforcement width) 508mm

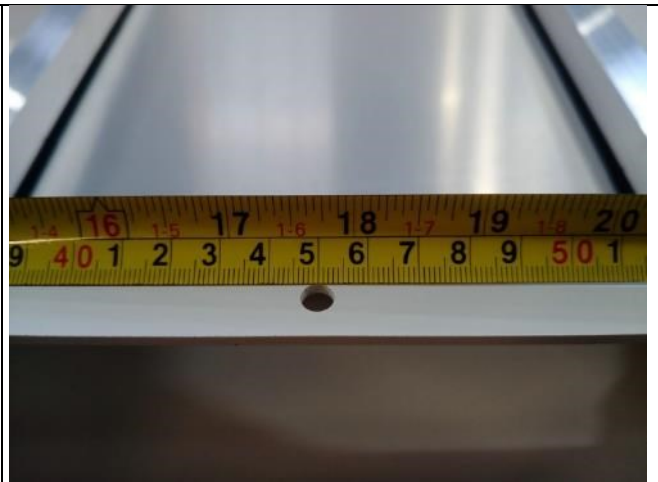
SPC 4: 450 - 10(Holes width) =350 mm

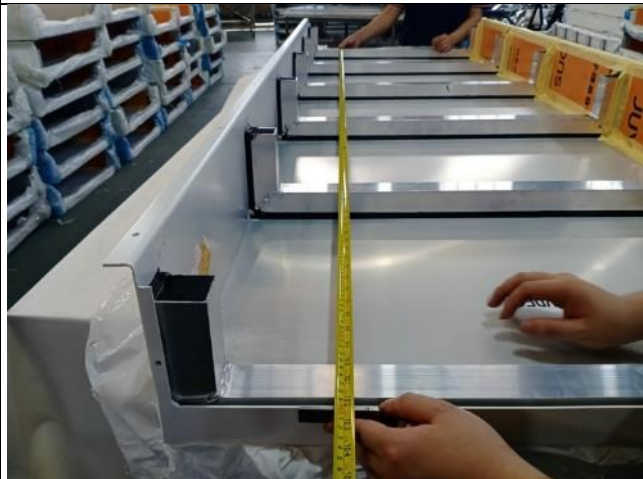
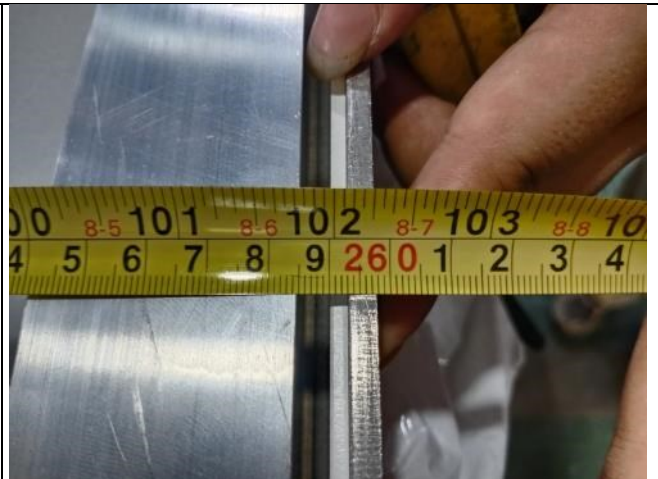
Box length: 2593mm

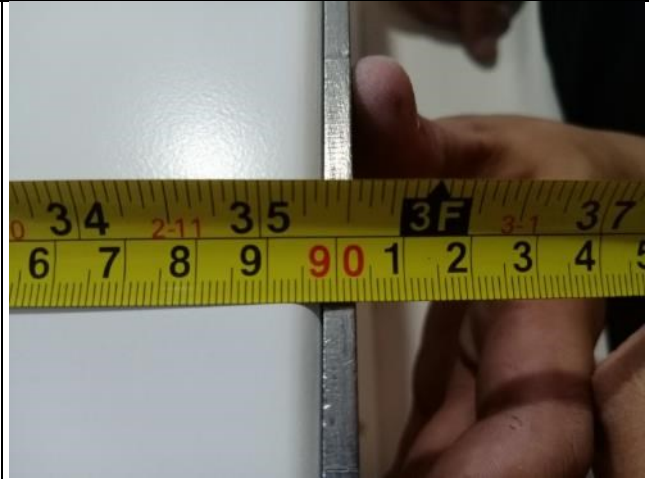
Box width: 898 mm

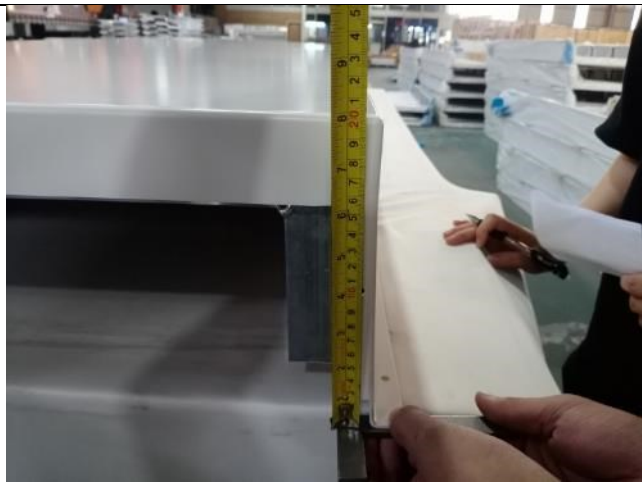
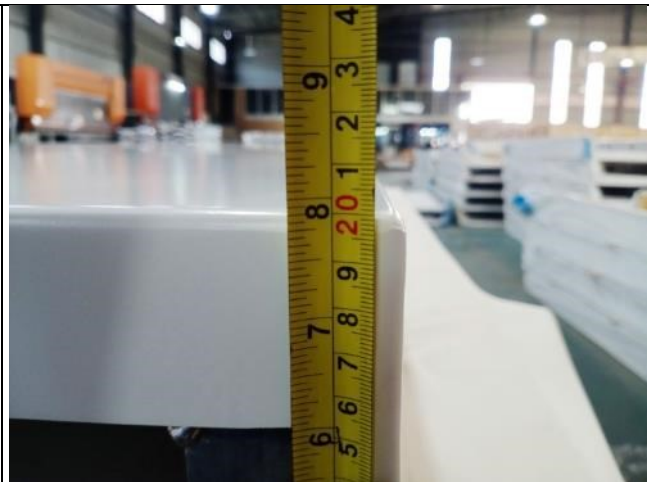
Edge length: 200mm

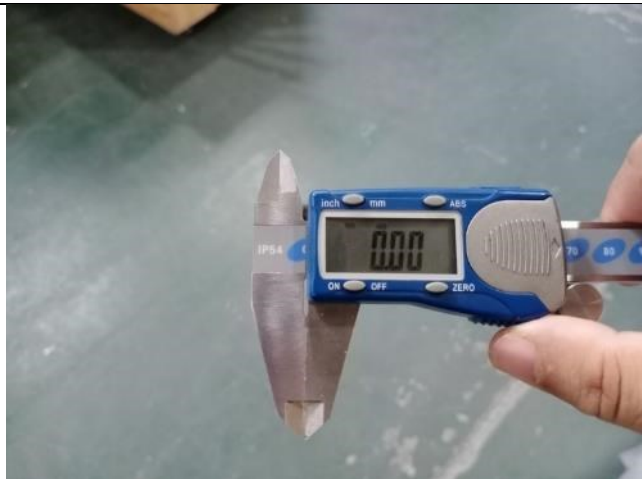
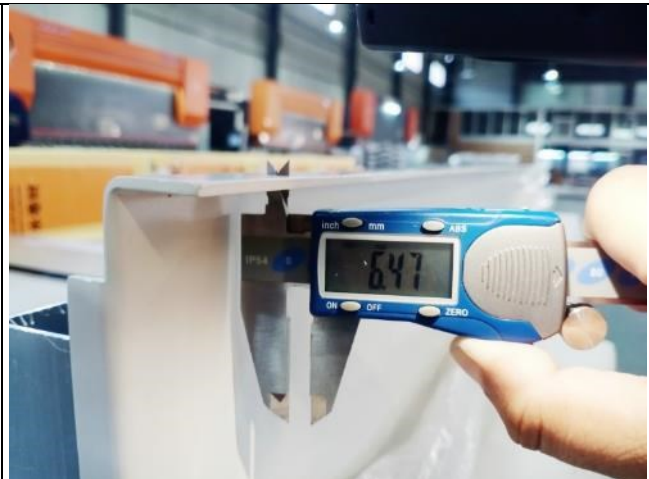
Hole width: 6.47mm

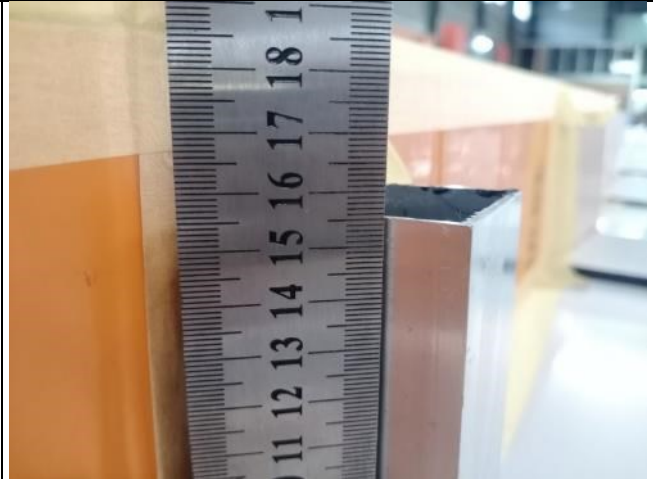
Reinforcement width: 45.17 mm

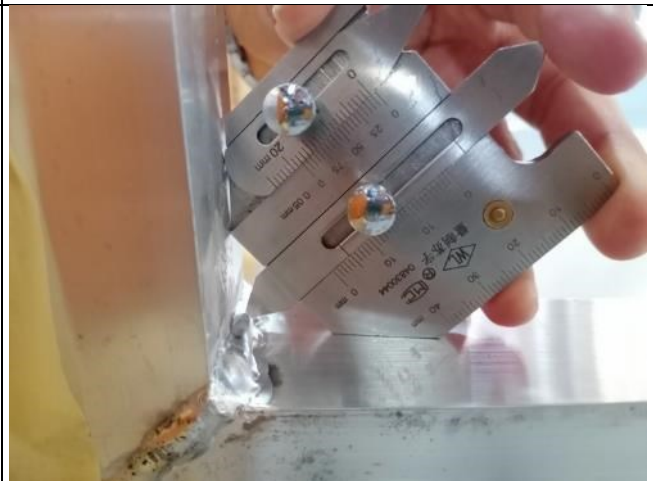
Thickness of reinforcement welding point: 4mm-5mm

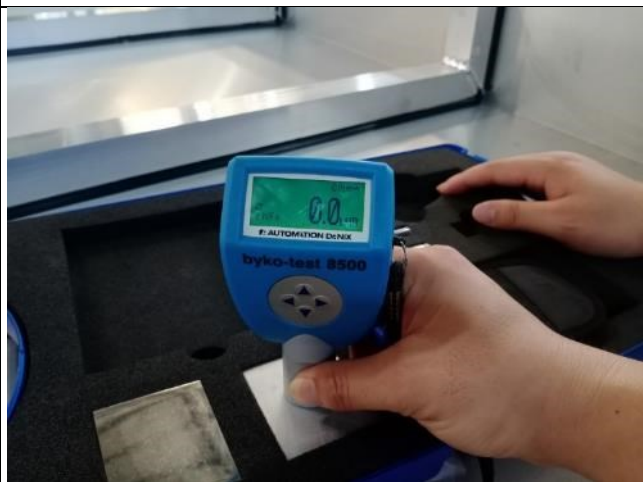
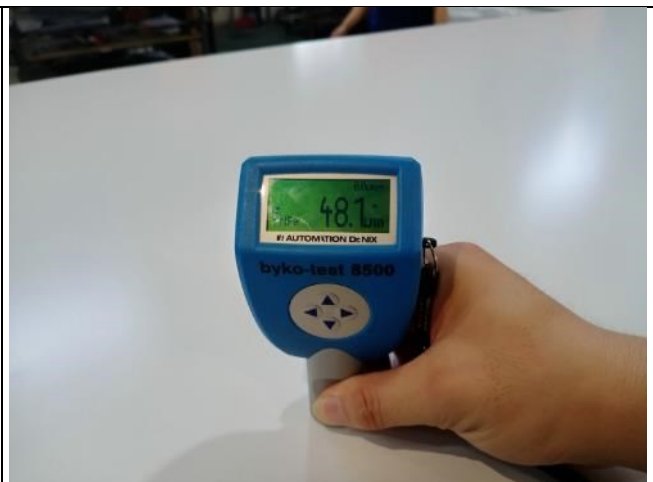
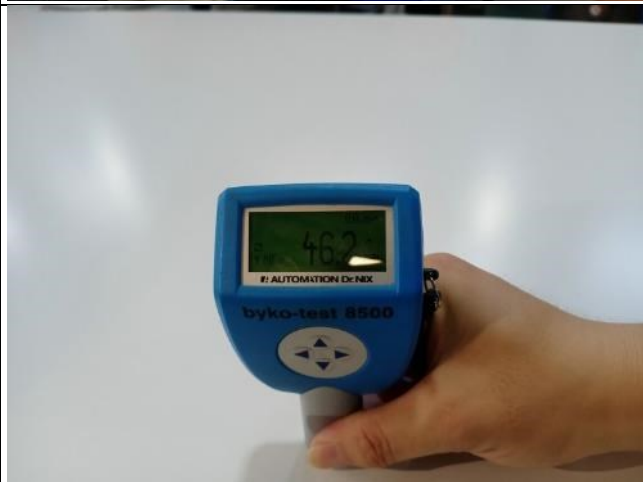
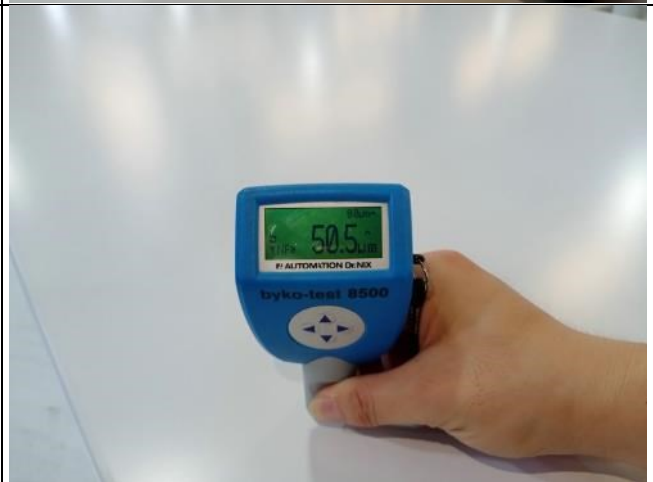
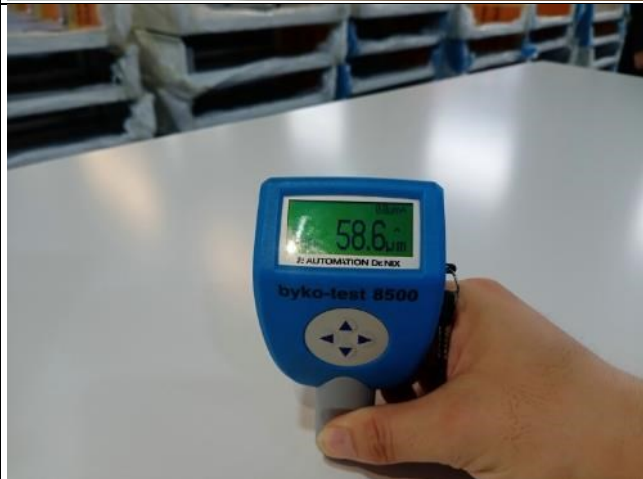
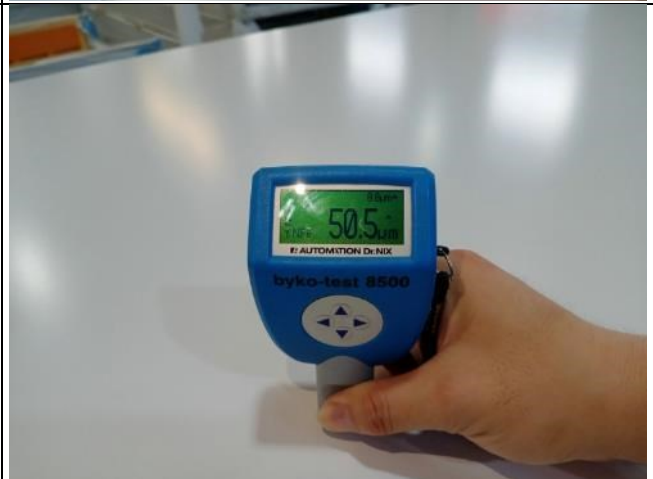
Color coating thickness: average  $253.9 / 5 = 50.78 \mu\text{m}$

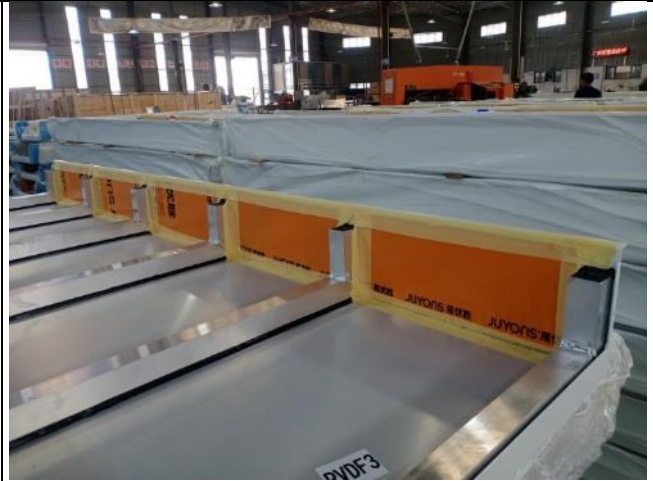
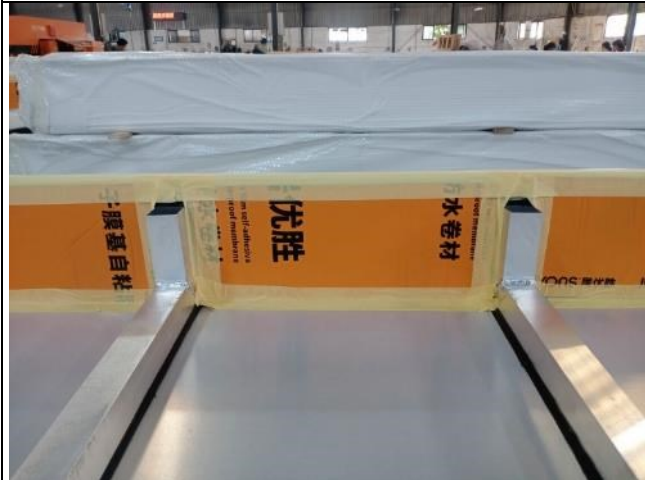
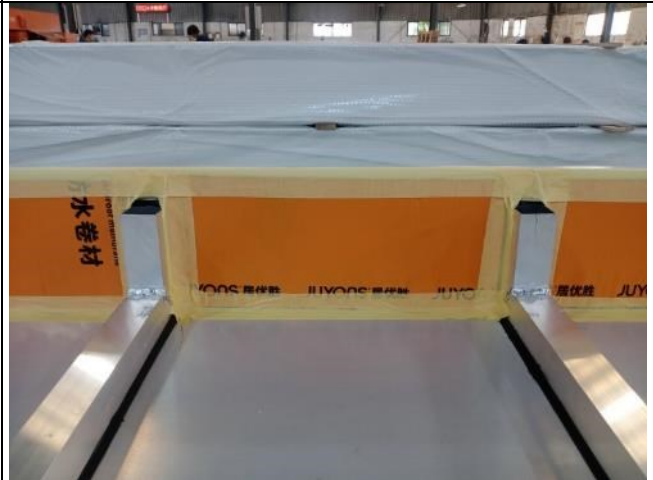
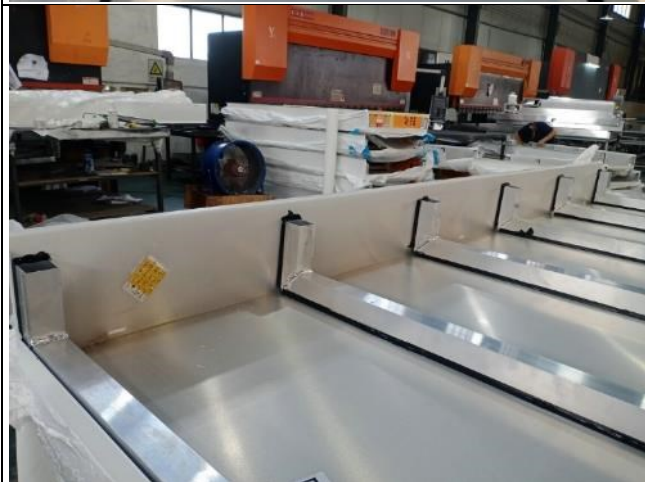
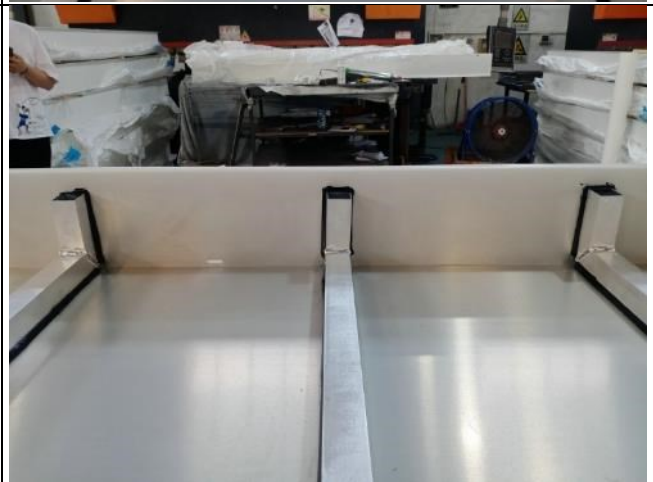
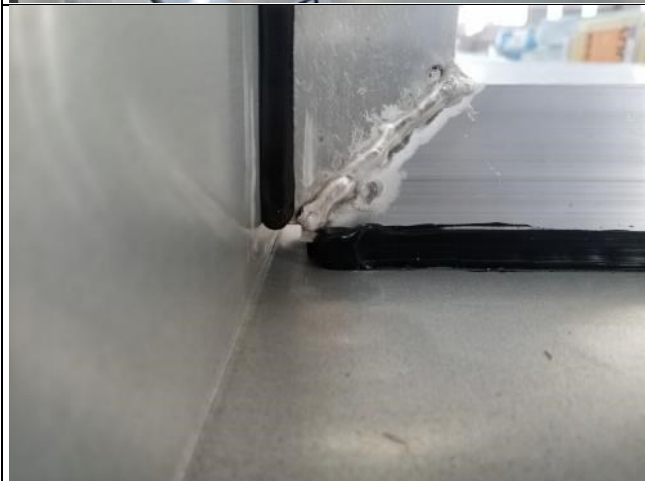
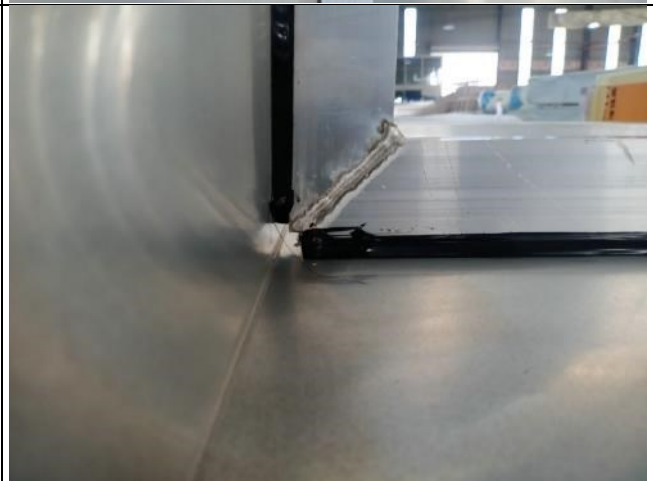
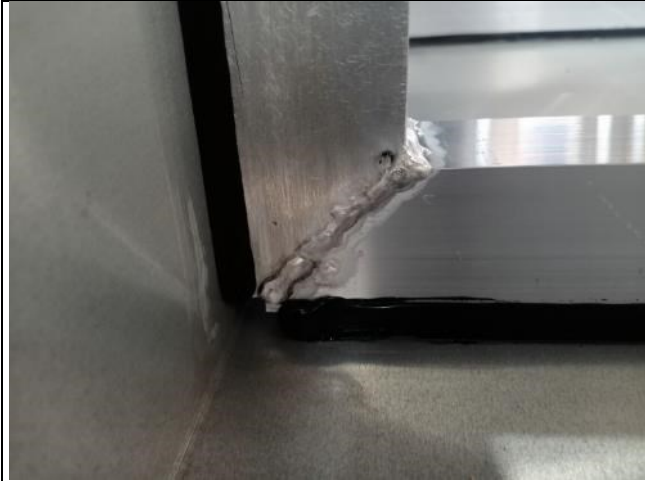
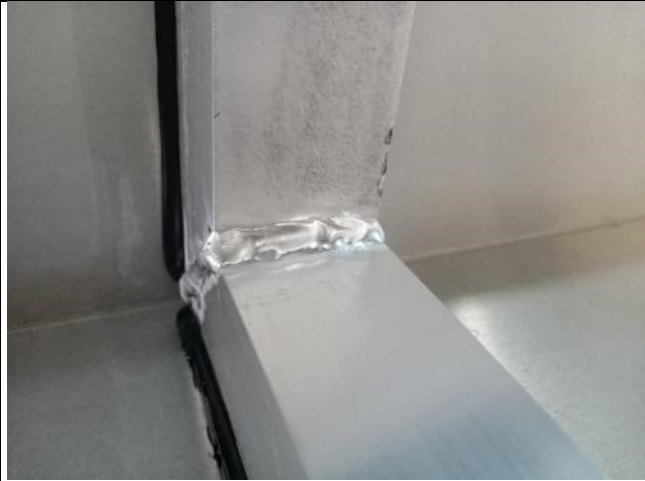
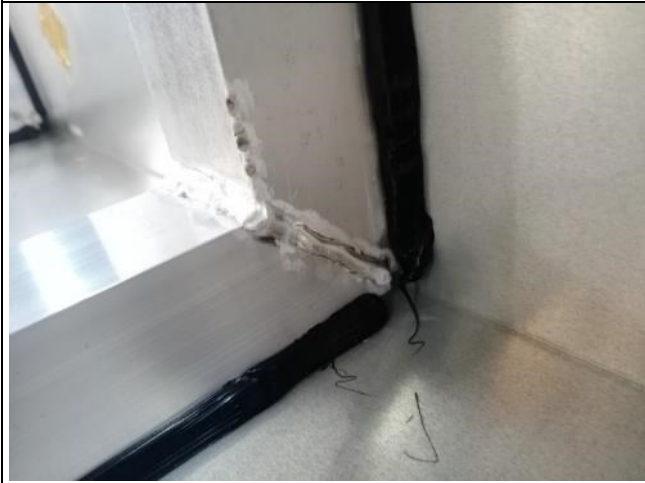
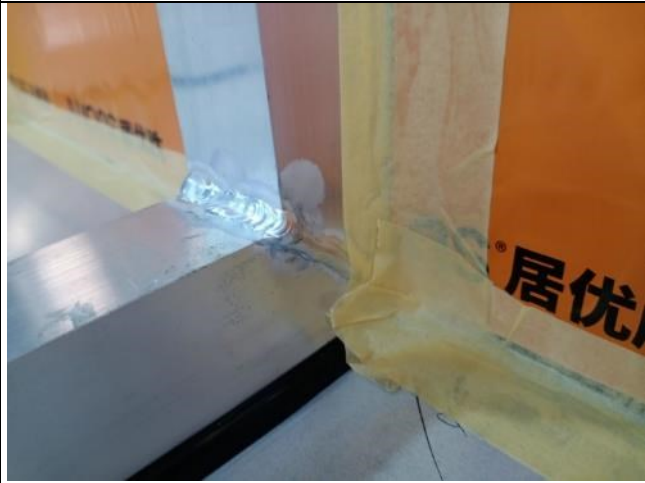
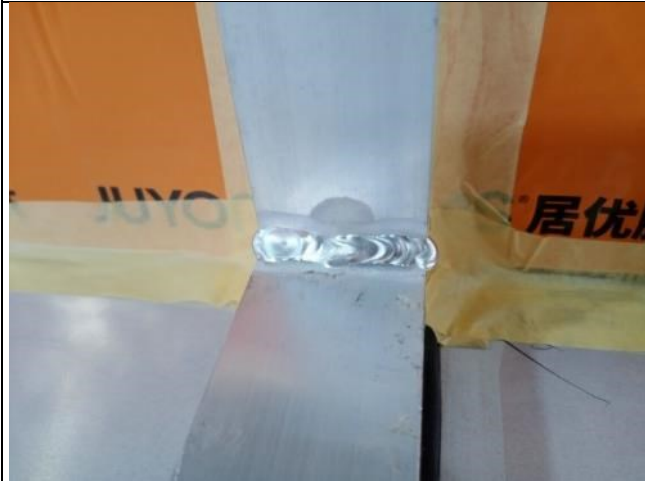
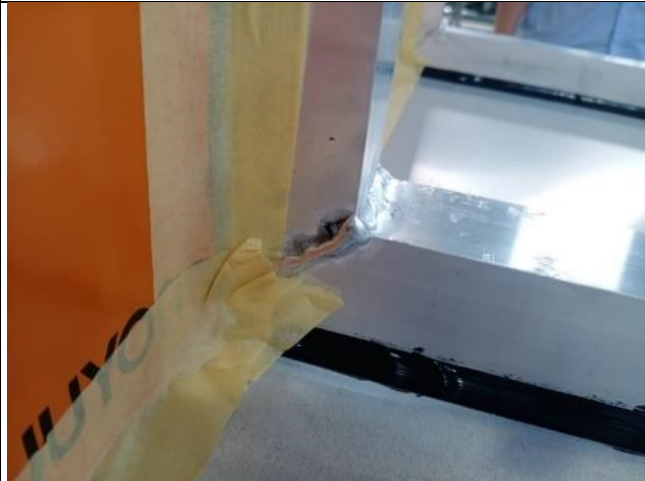
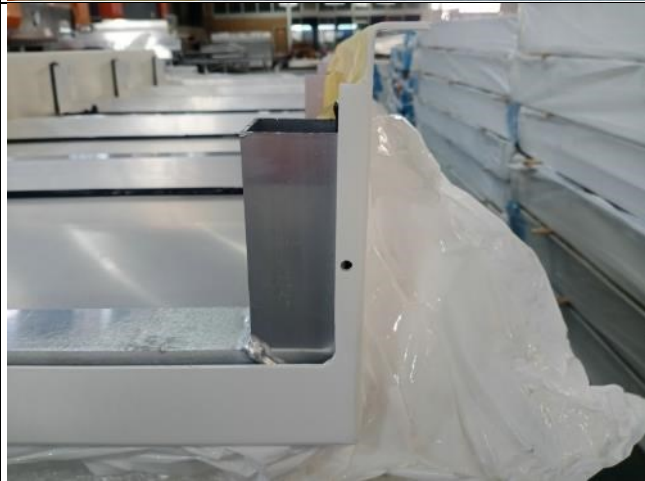
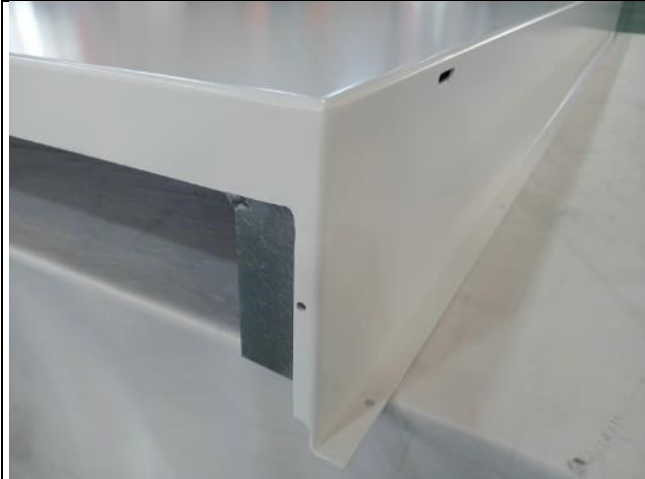
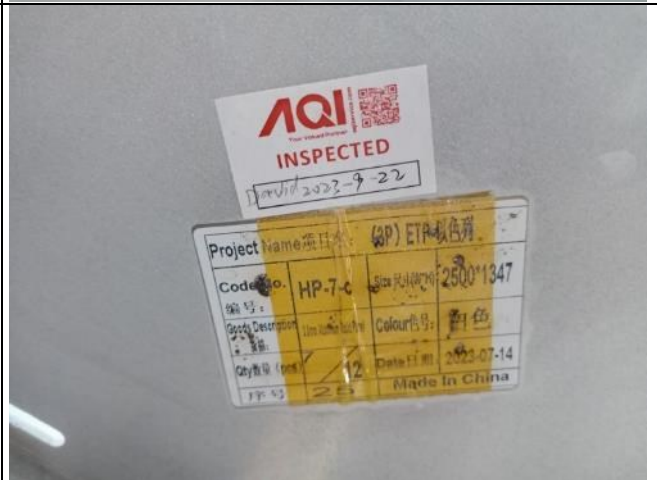
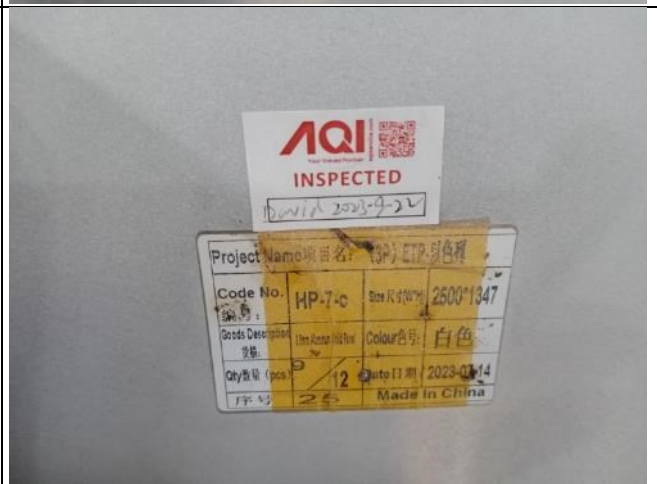
Item: HP-7

| HP-7 | Damaged edges and corners with paint | 0 | 2 | 0 | |
