# Pre-shipment Inspection Report

Report #: PSI20230921&22-R2309133838

| General Information: | |
|---|---|
| Product name | Alum Box |
| PO# | 22003978 |

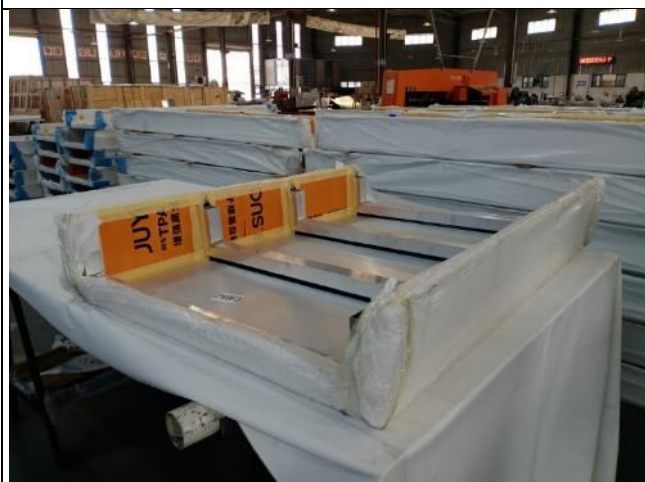
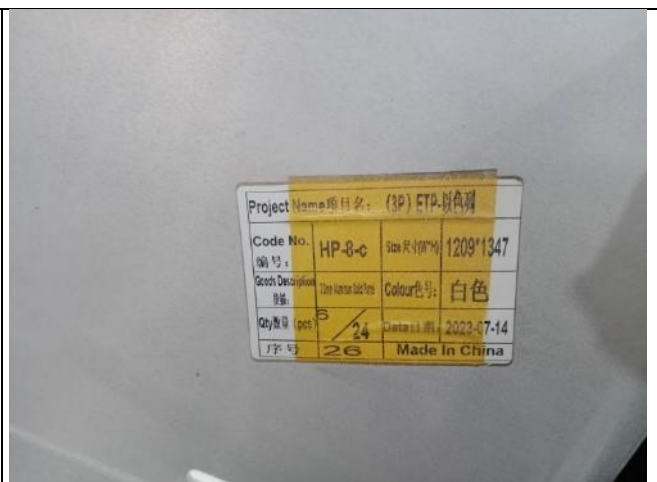
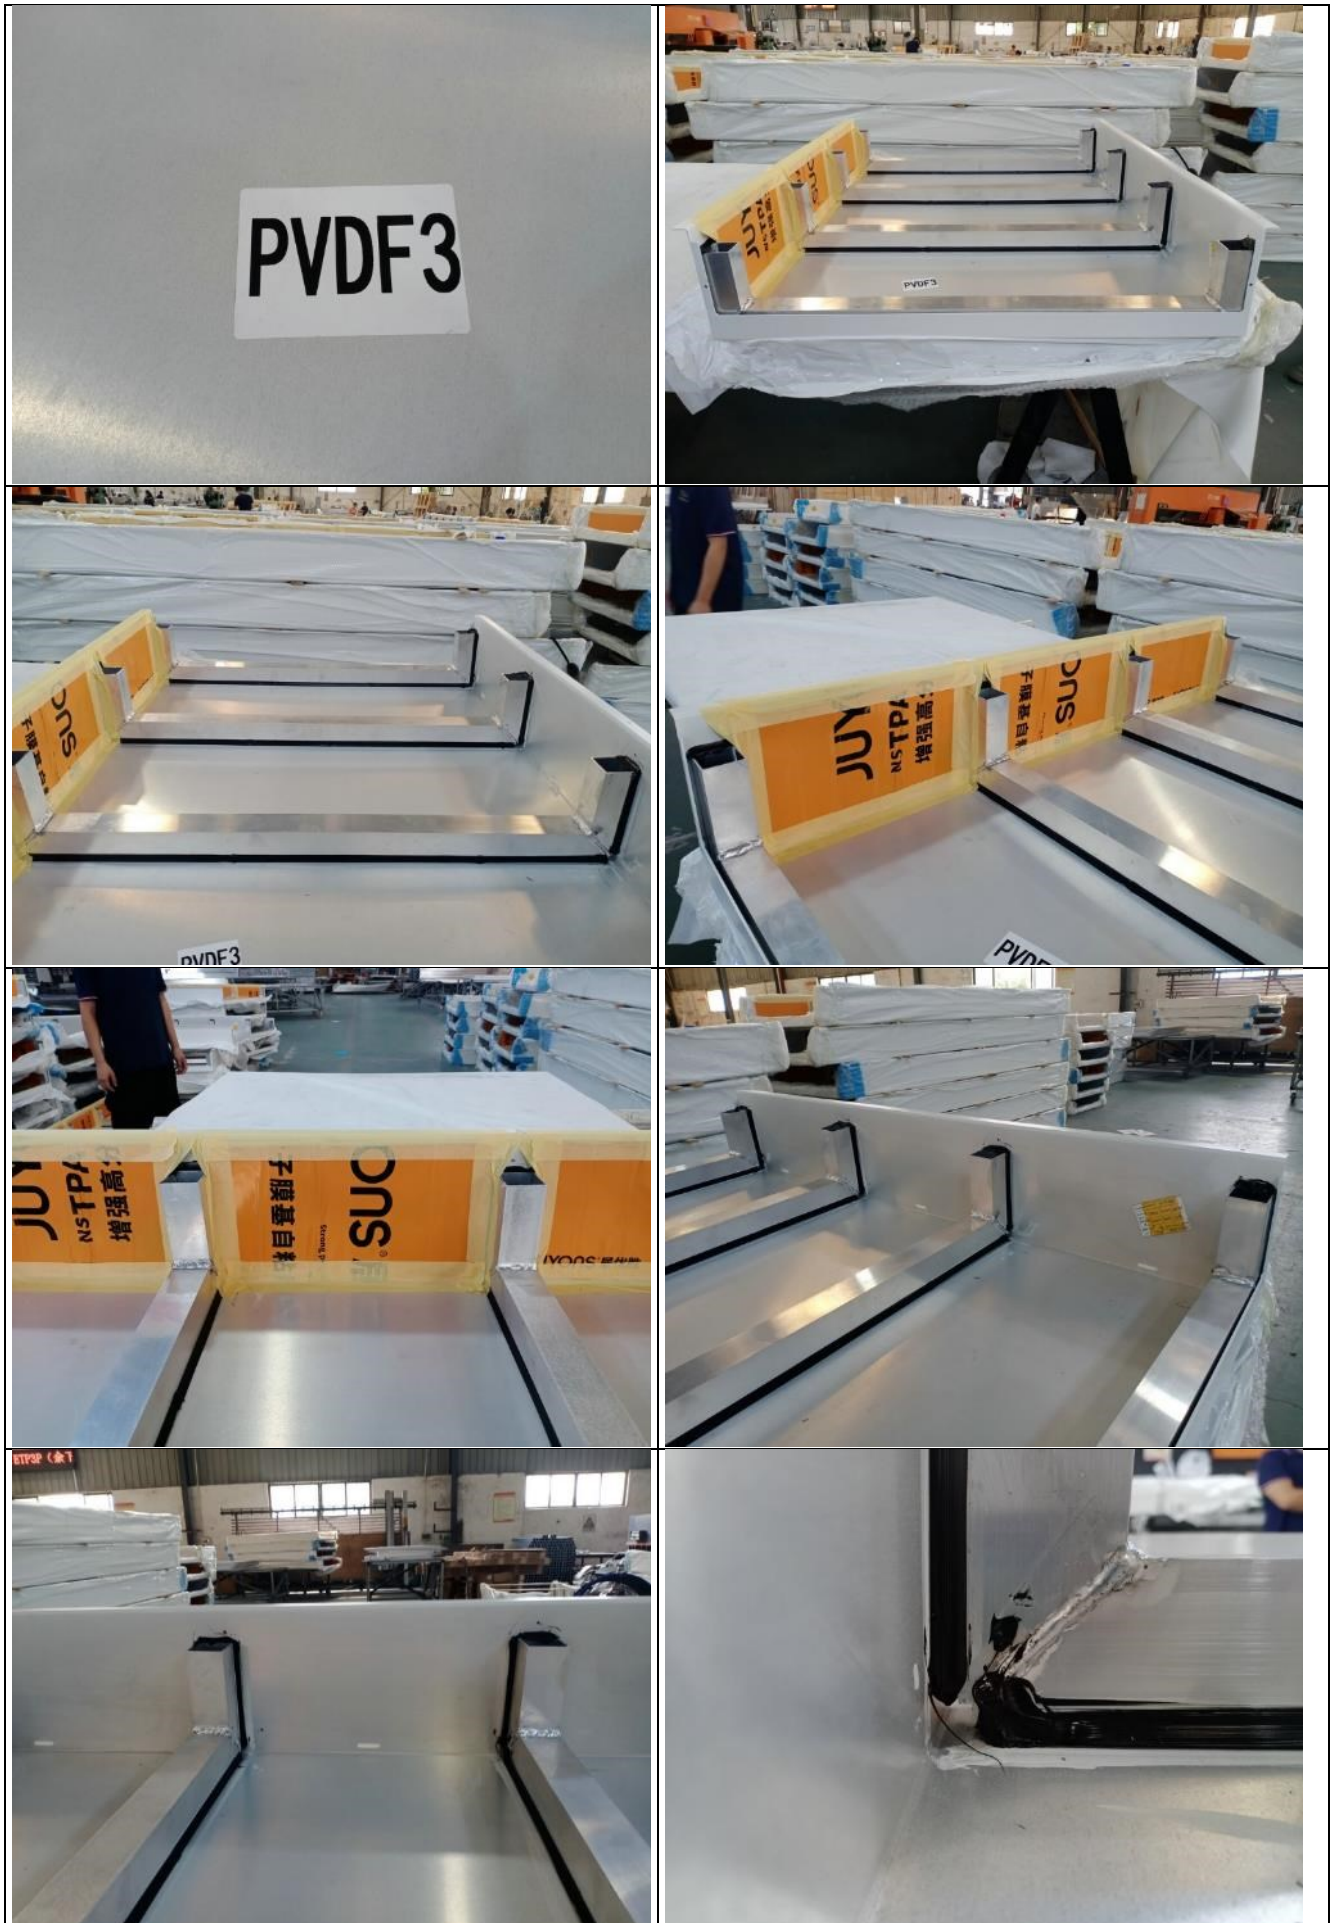
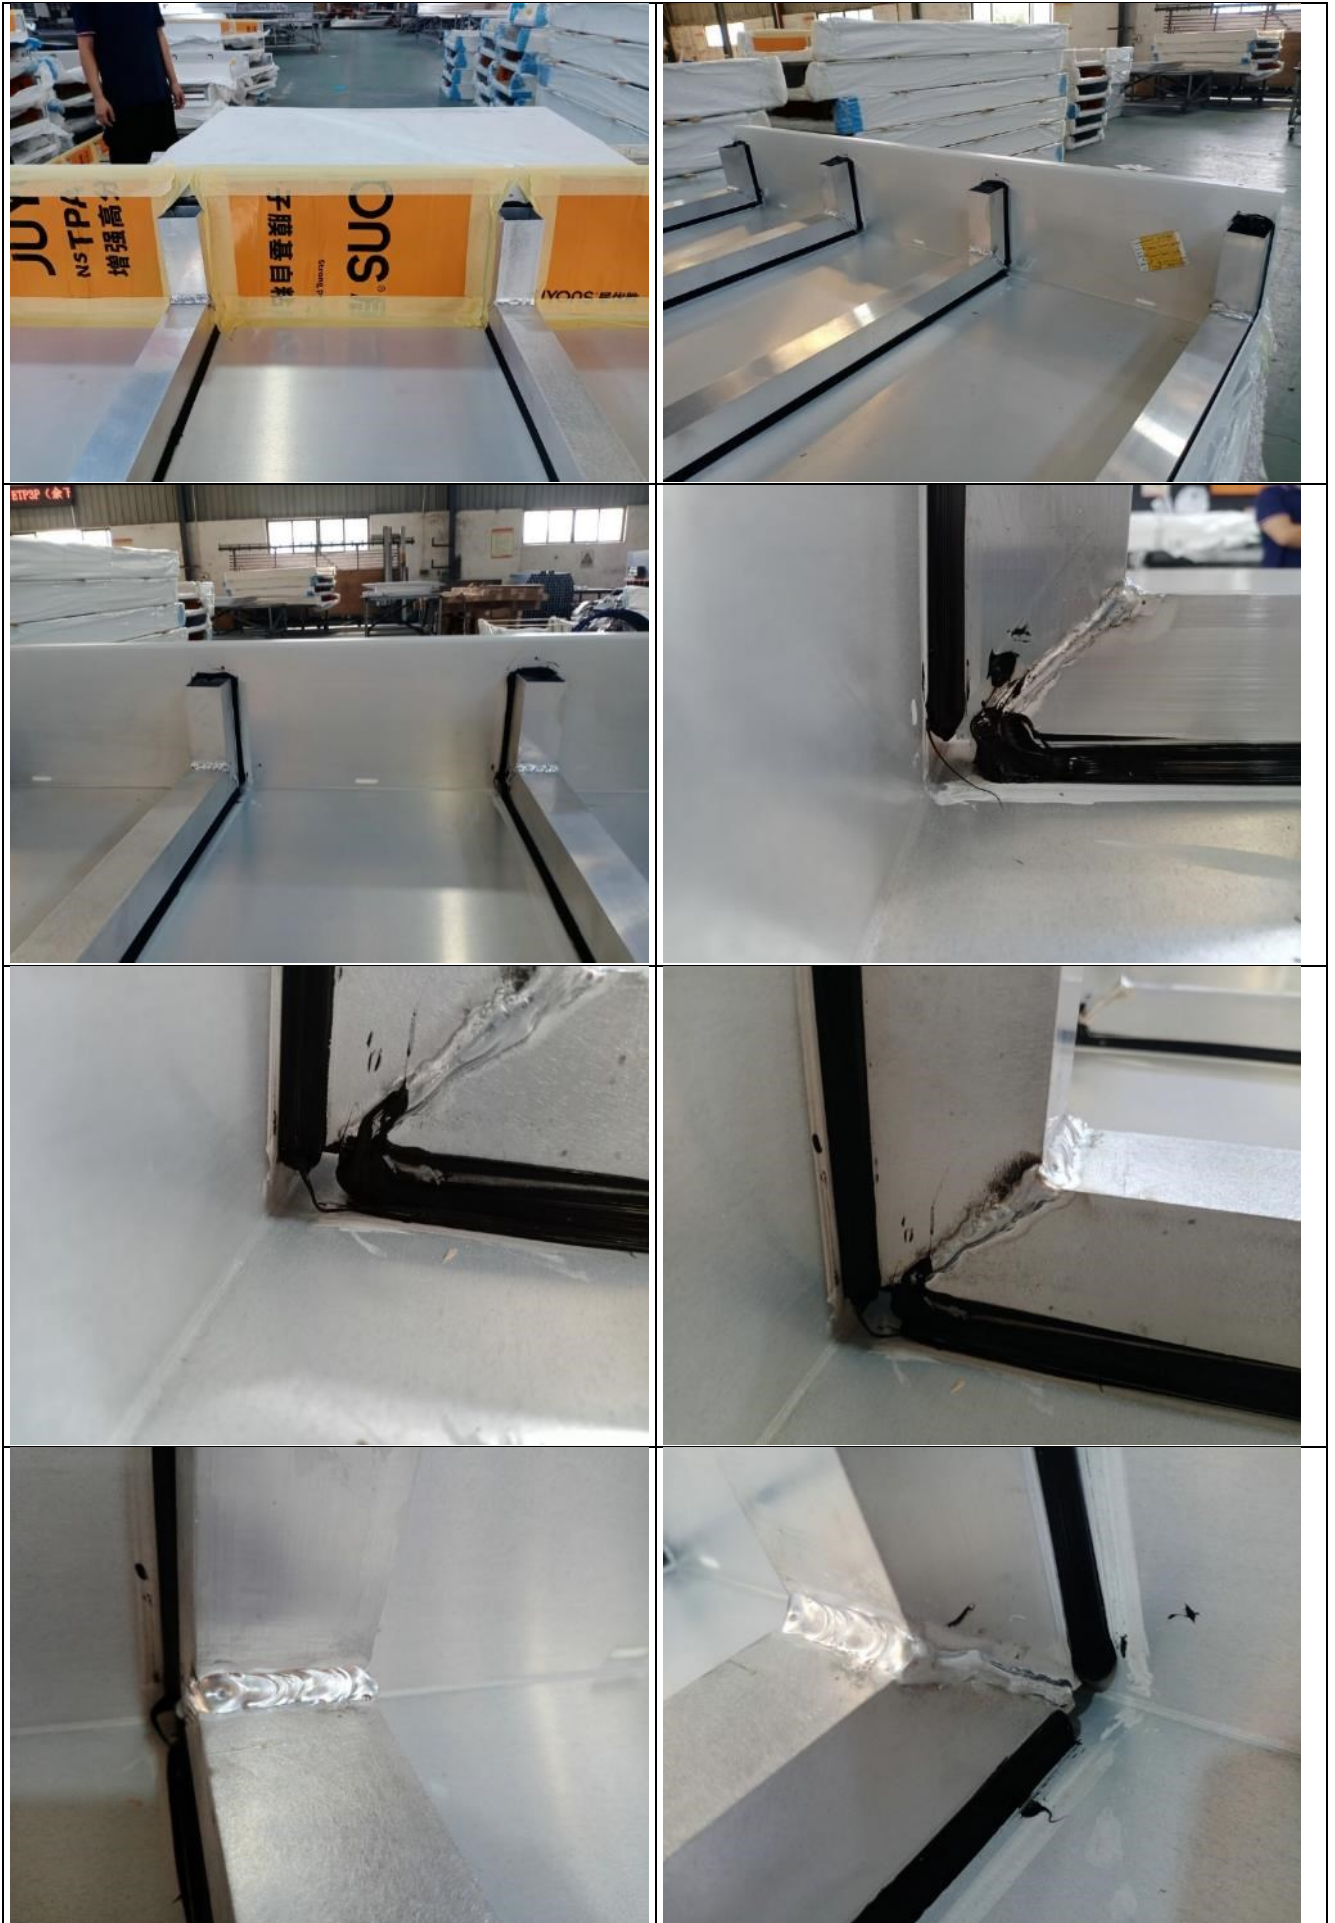
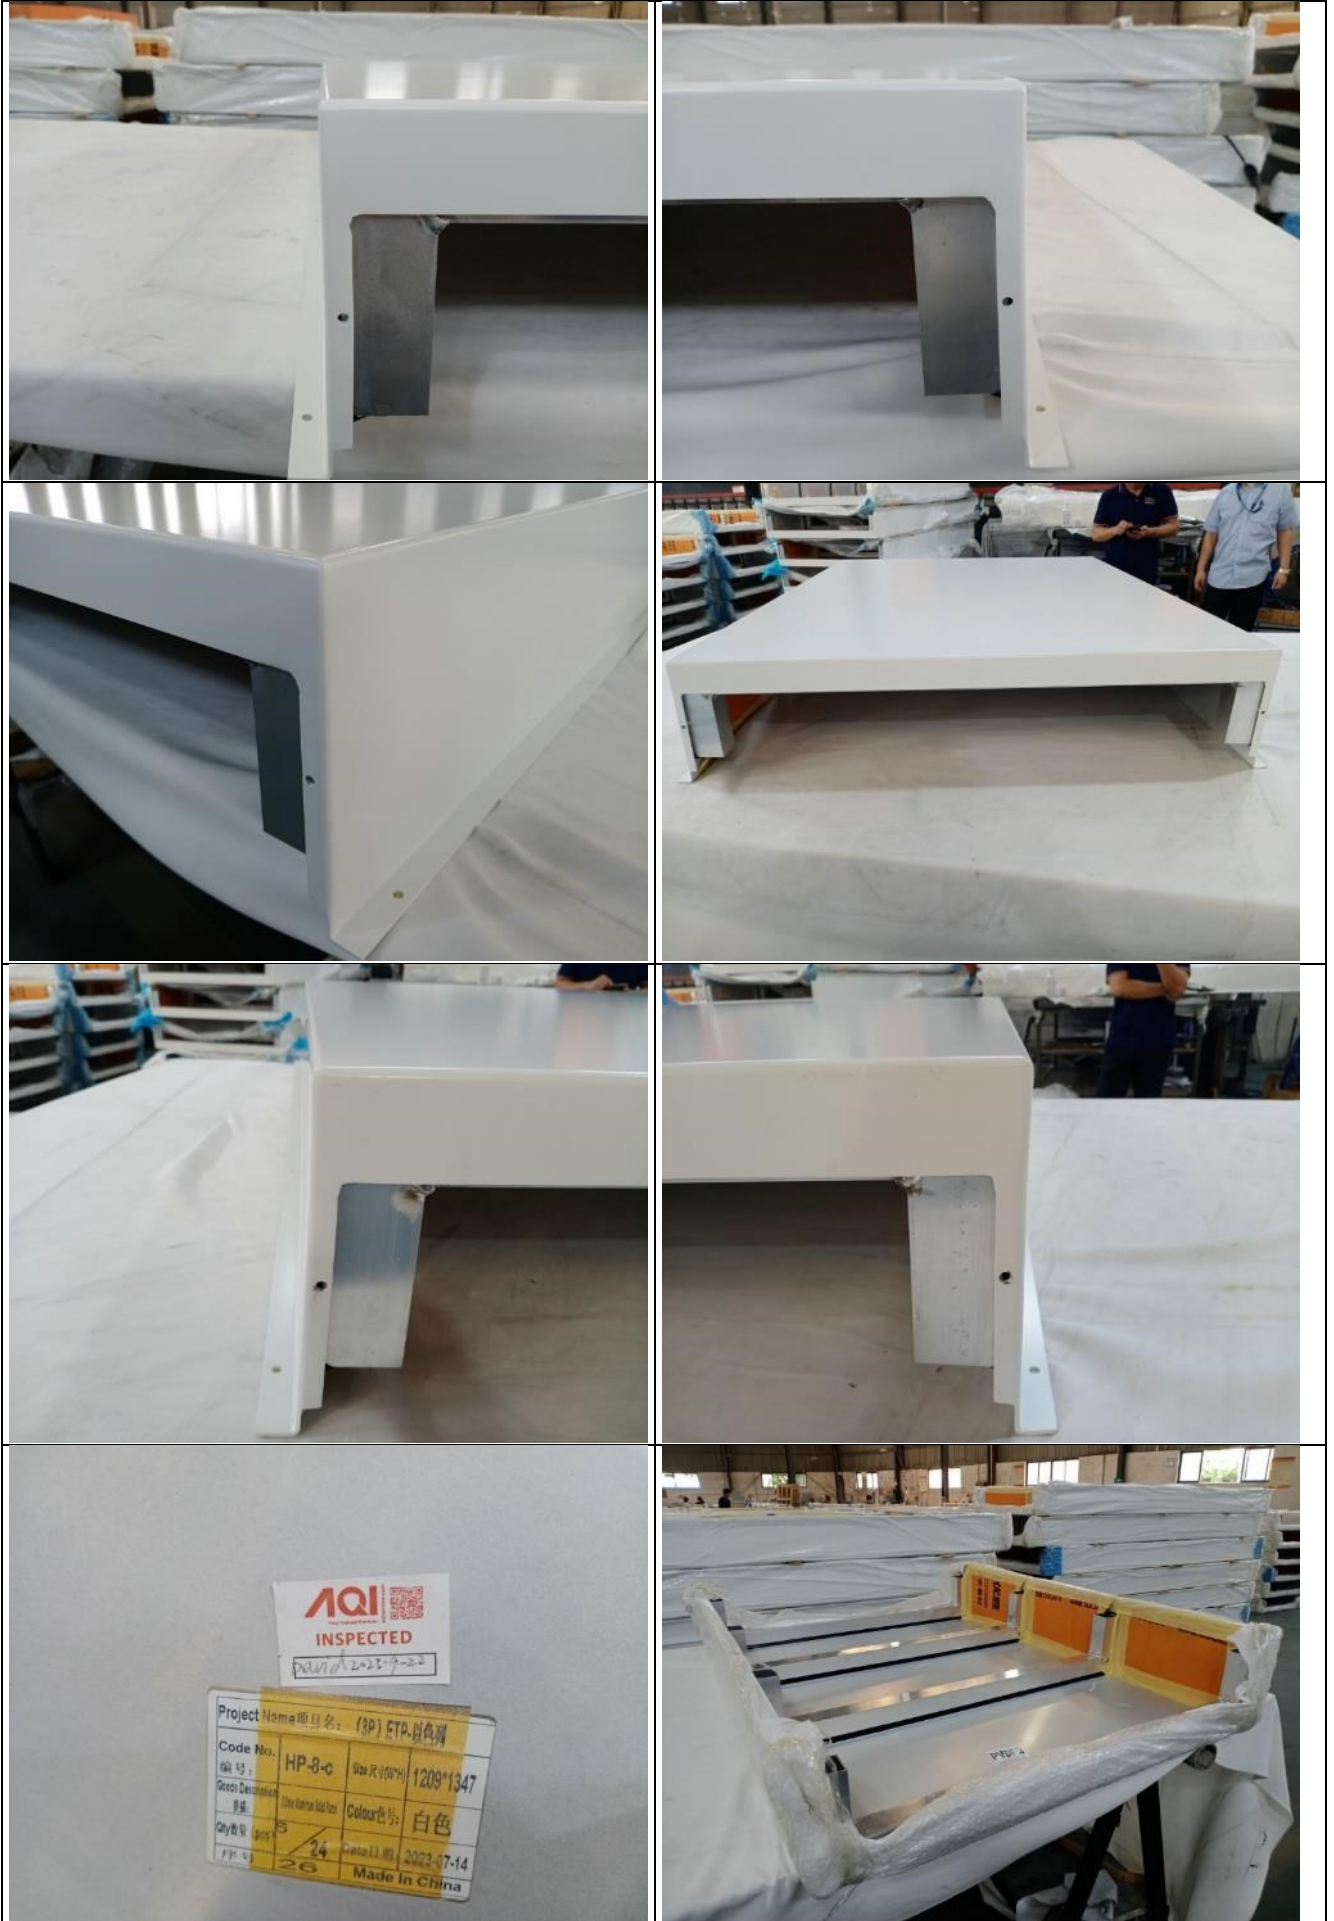
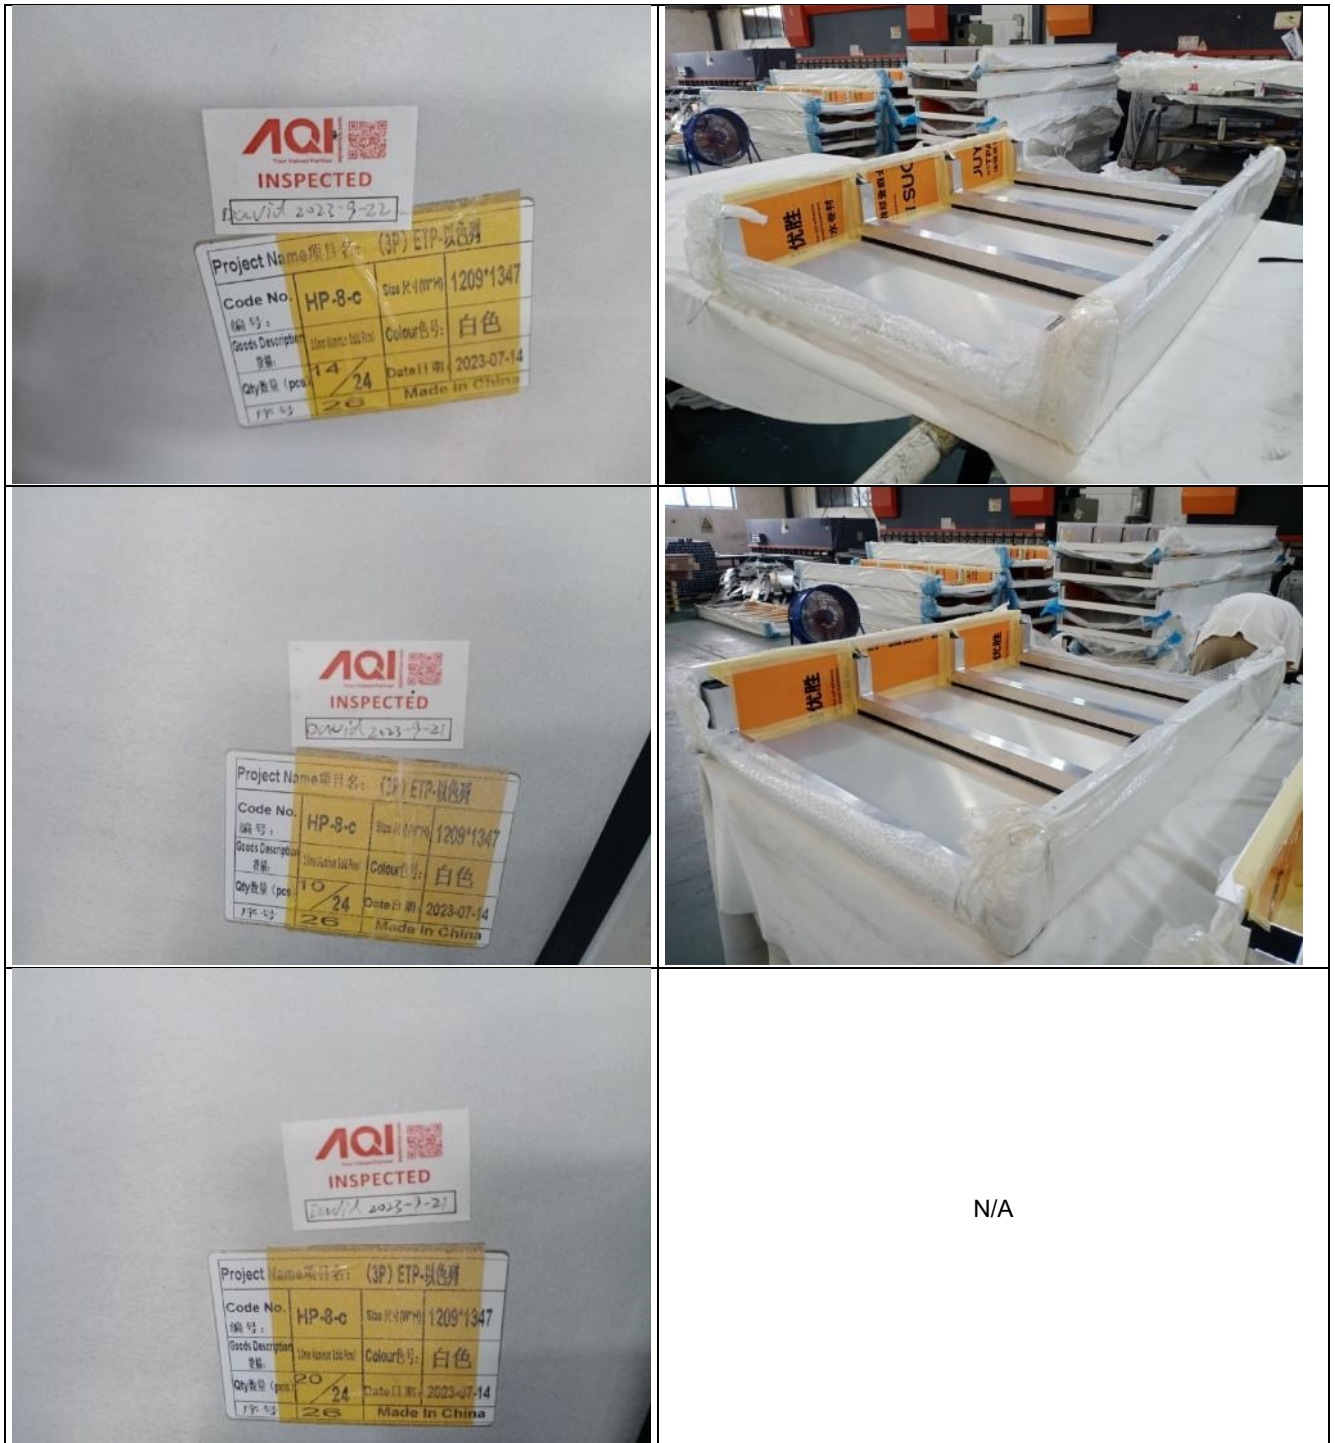
Item: HP-8

| HP-8 | Damaged edges and corners with paint | 0 | 2 | 0 | |
