# Pre-shipment Inspection Report

Report #:PSI20200413-200331-H

| General Information: | |
|---|---|
| Product name | SUNGLASSES |

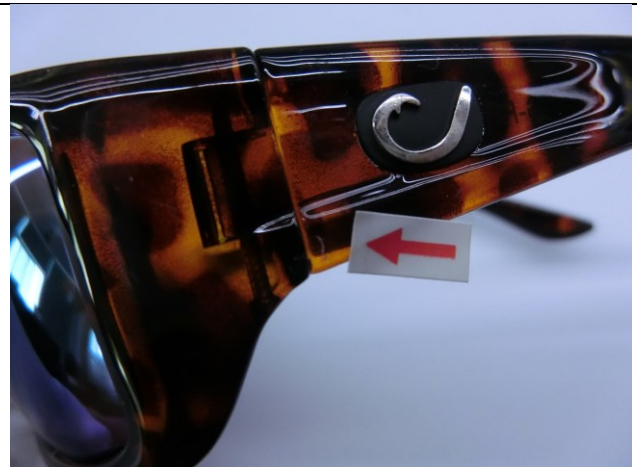
Foreign mater on frame-minor

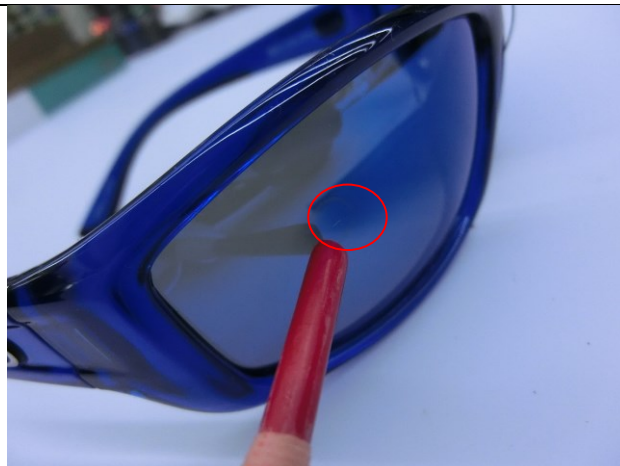
Dirty mark on lens-minor

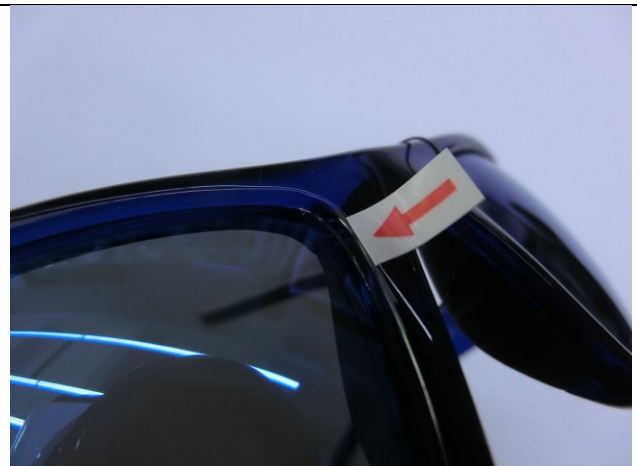
Dirty mark on lens-minor

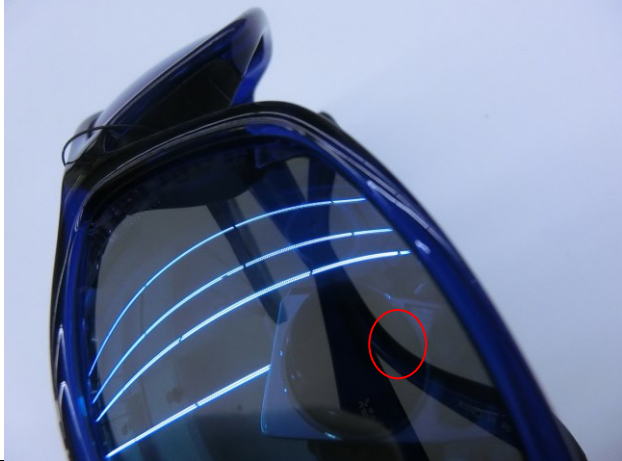
| <p>Scratch mark on lens-minor</p> | <p>Particle on frame-minor</p> |

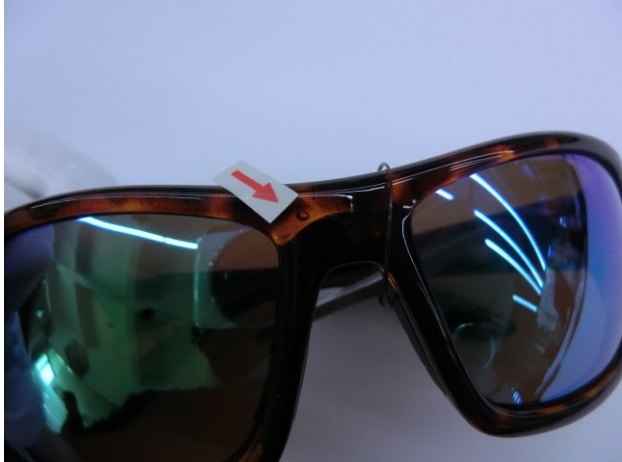
| <p>Bubble on frame-minor</p> | <p>N/A</p> |

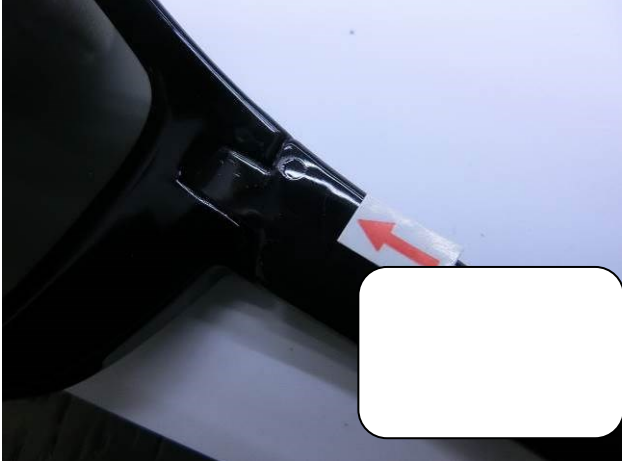
| <p>Item:91066</p> | |

| <p>Scratch mark on frame-minor</p> | <p>Bubble on frame-minor</p> |

| 91066 | Scratch mark on frame | | | 1 | Replaced |

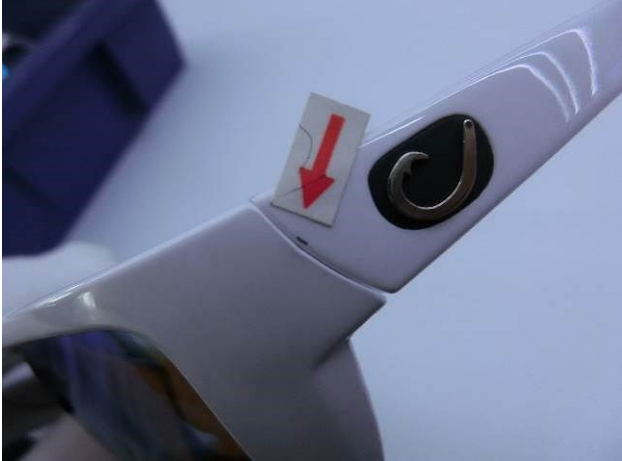
| <p>Dirty mark on frame-minor</p> | <p>N/A</p> |

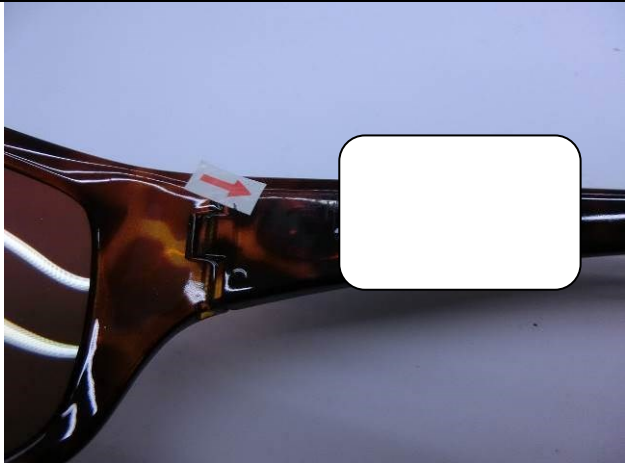
| <p>Item:91207</p> | |

| Glue mark on frame-minor | Scratch mark on frame-minor |

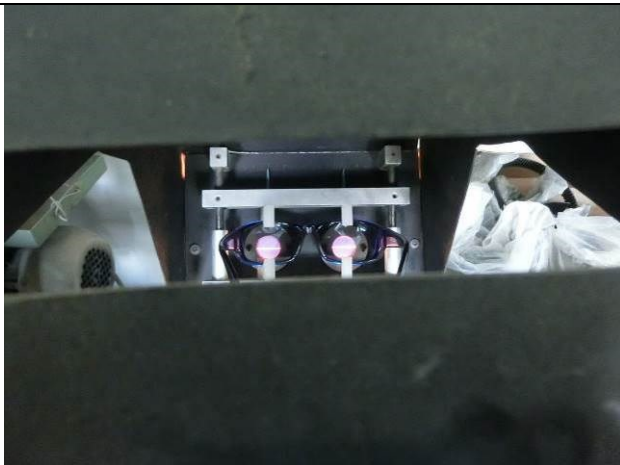
| 3.2. | For 91207 Smoke/Blue Mirror Polarized light test, found result was 9-10 degree beyond +/-3 degree. |

| # | Testing Description | Sample Size | Result | Remark |
|---|---|---|---|---|
| 3.4. | Polarized light test | 1 pc/item | Pending | For 91207 Smoke/Blue Mirror Polarized light test, found result was 9-10 degree beyond +/-3 degree. |

Polarized light test

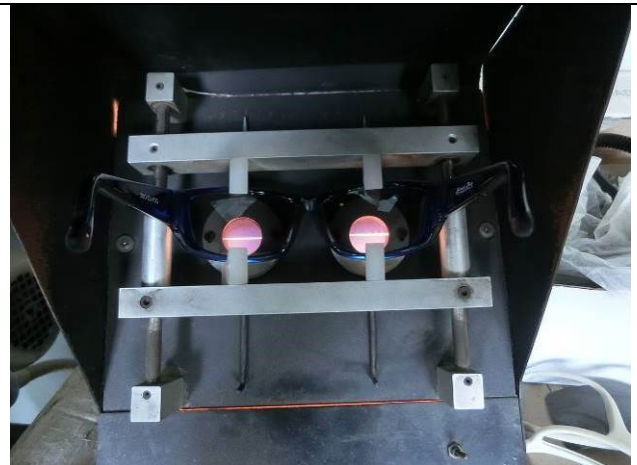
Polarized light test

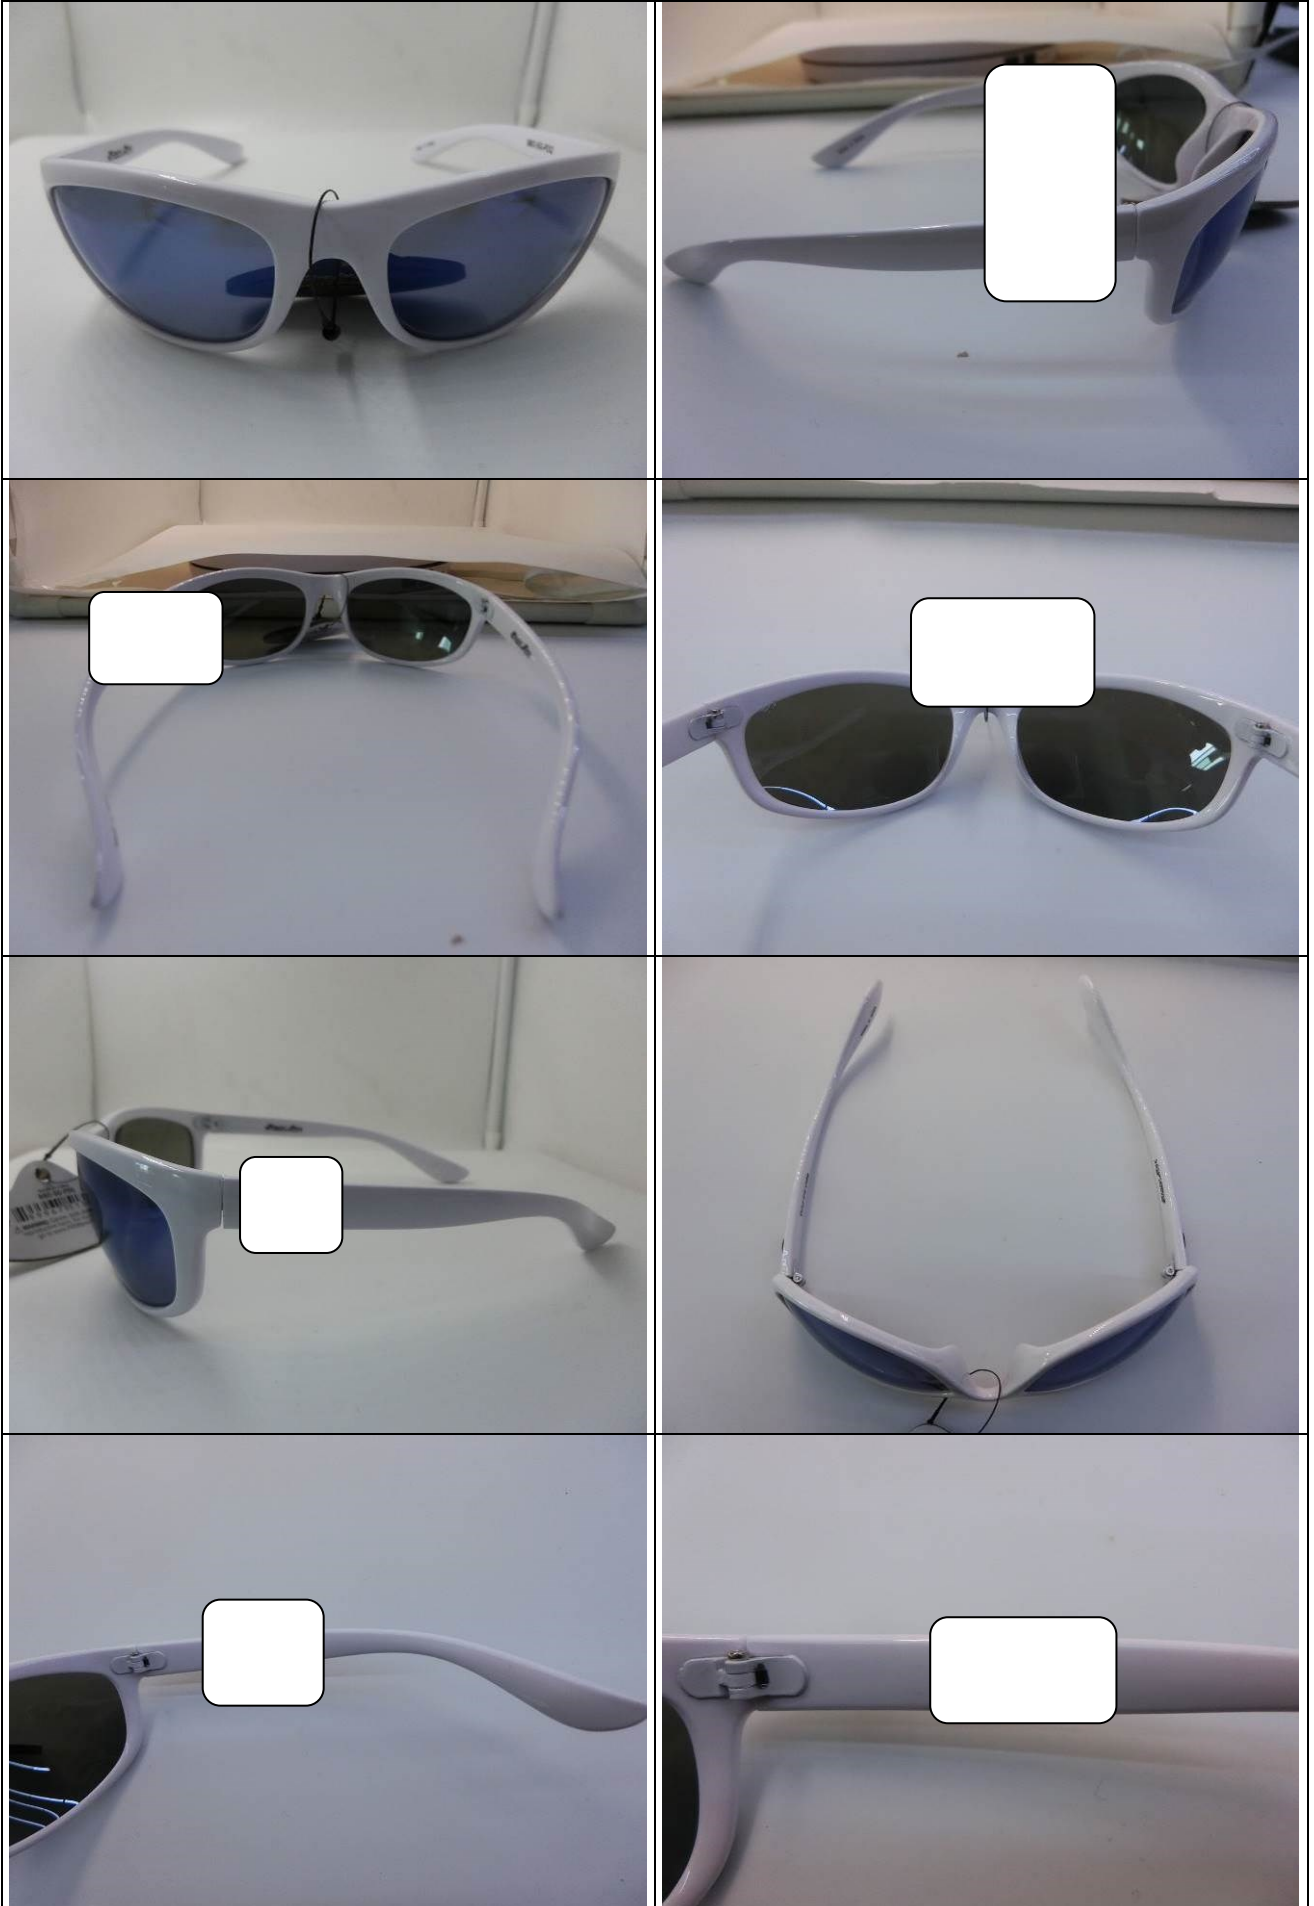
91201 Gloss White  
Smoke/Blue Mirror

| # | Check Points | Result | Remarks |
|---|---|---|---|
| 6.3 | Product size/Weight | Pending | Actual found |

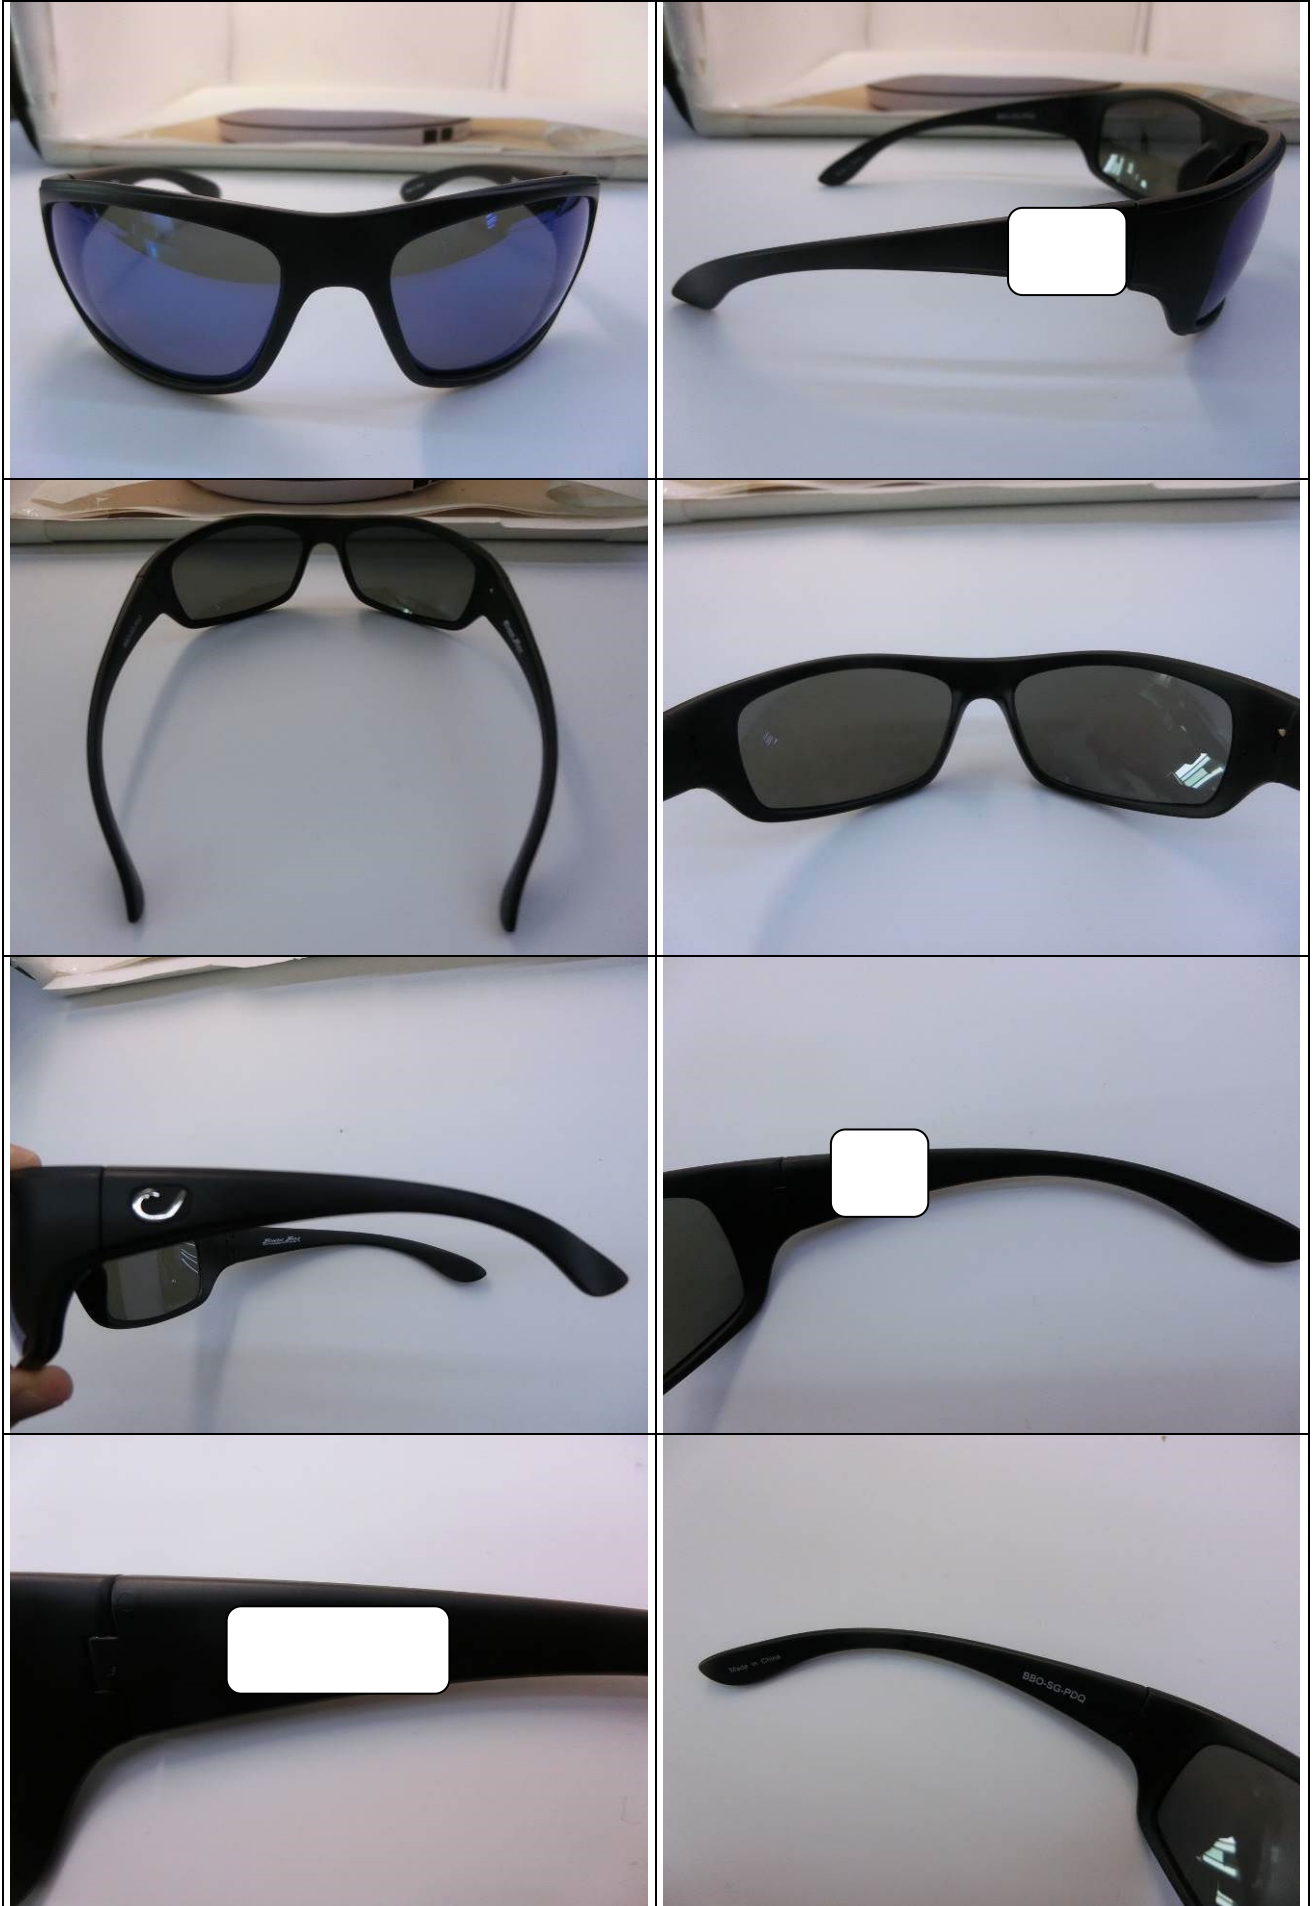
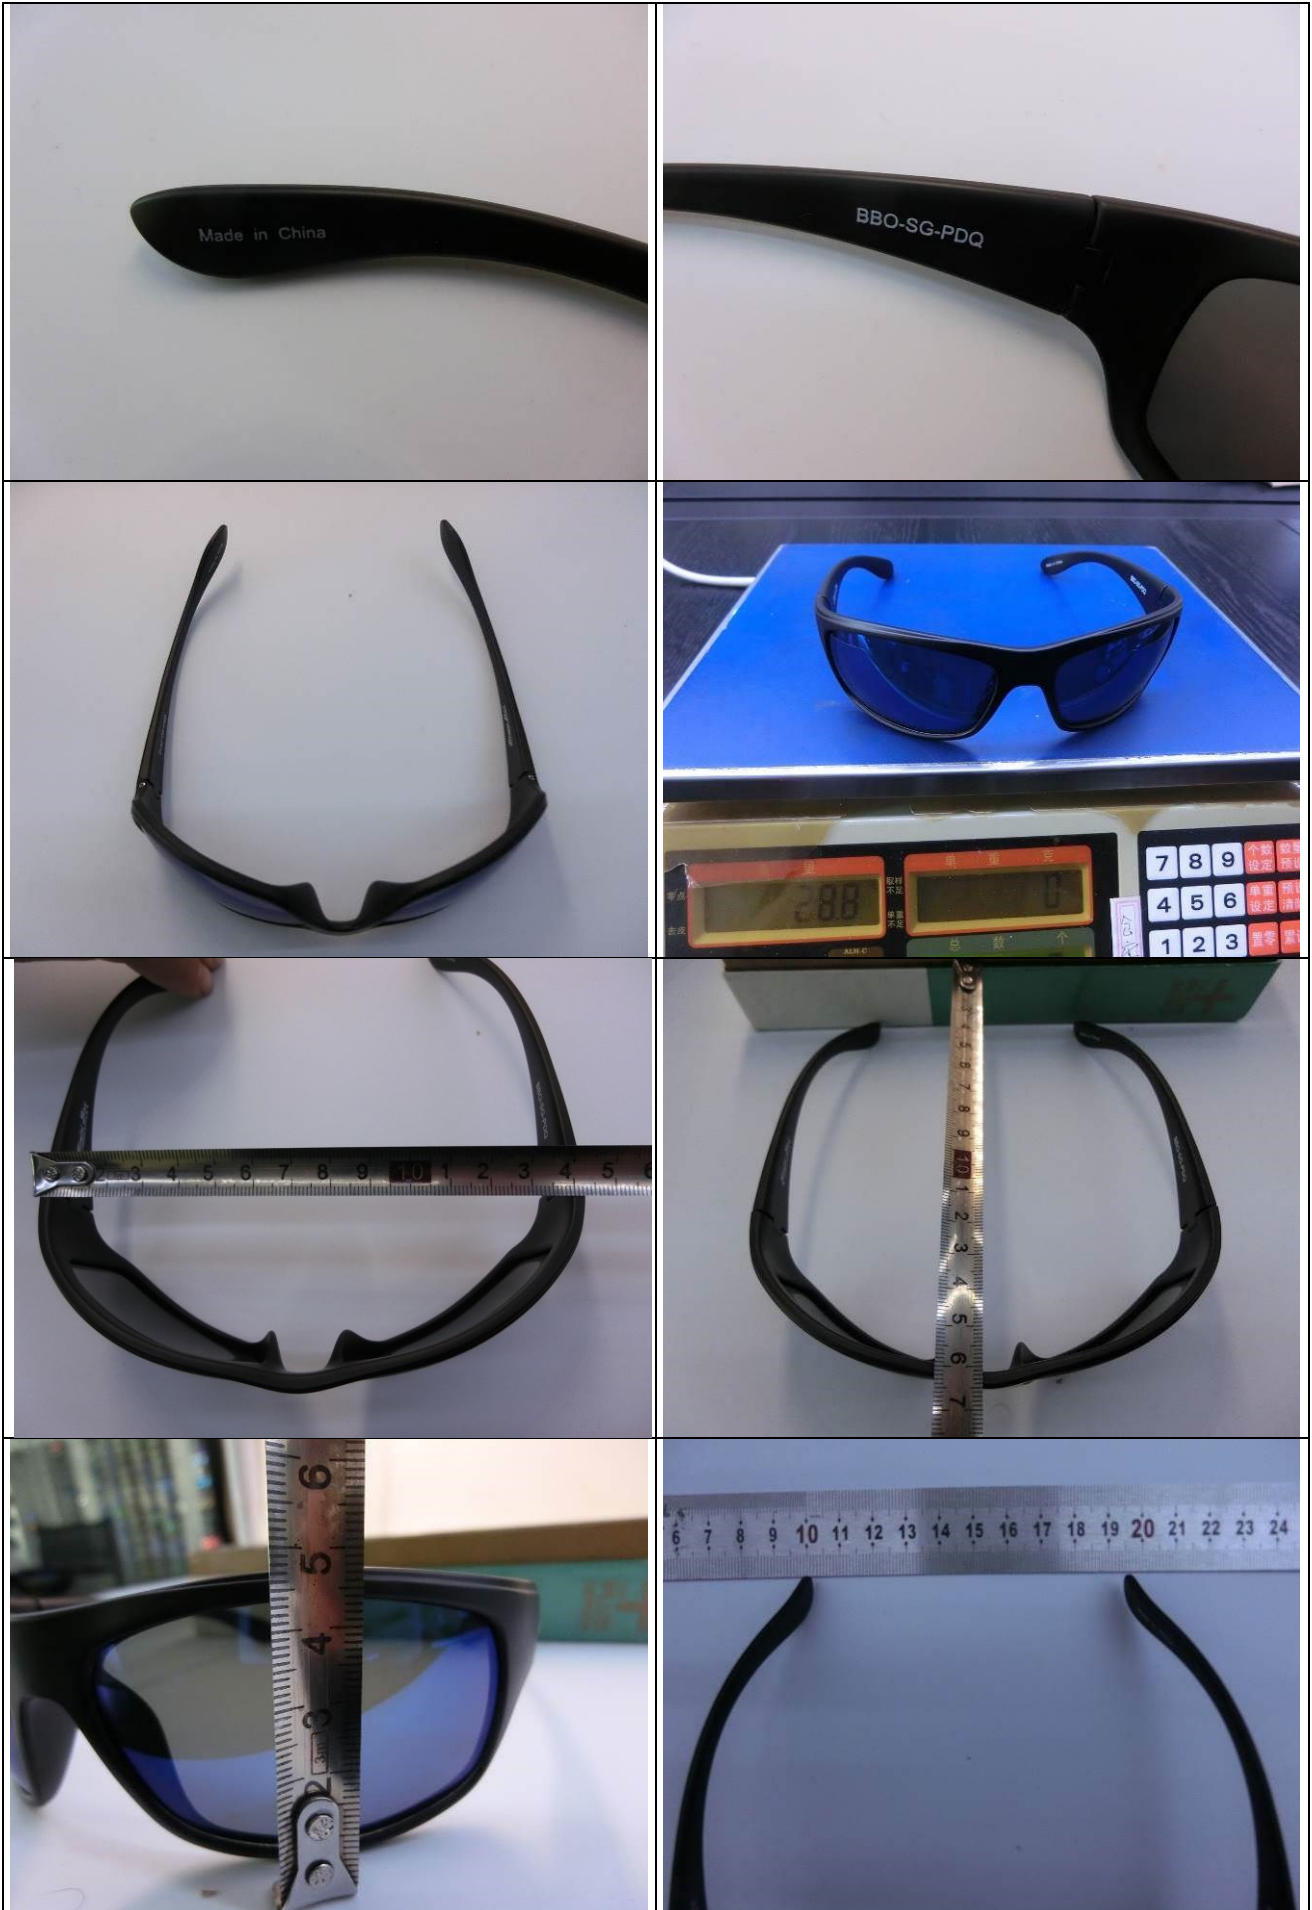
91207 Matte Black  
Smoke/Blue Mirror

Remark #3.2: For 91207 Smoke/Blue Mirror Polarized light test, found result was 9-10 degree beyond +/-3 degree.
